ARBORIST REPORT AND TREE PROTECTION PLAN

CA-7225

9300 Mill Station Rd.
Sebastopol, CA

October 2023

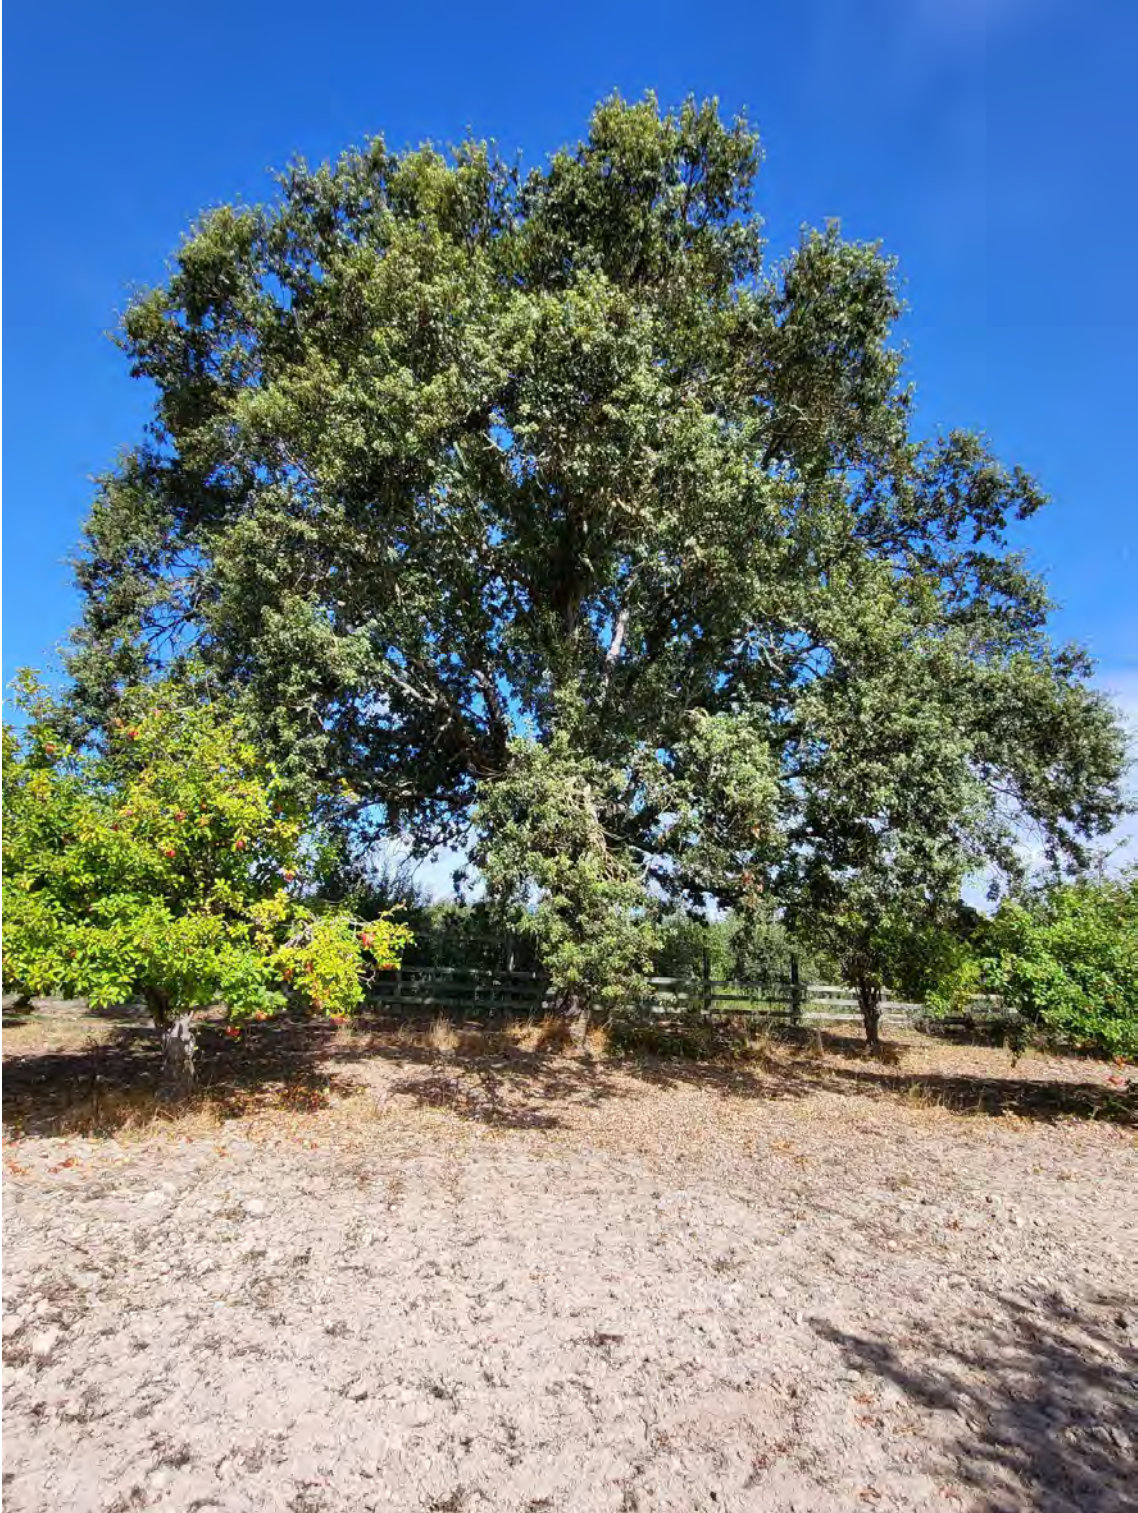
Photo 1. Tree #1 is a valley oak tree in overall good condition.

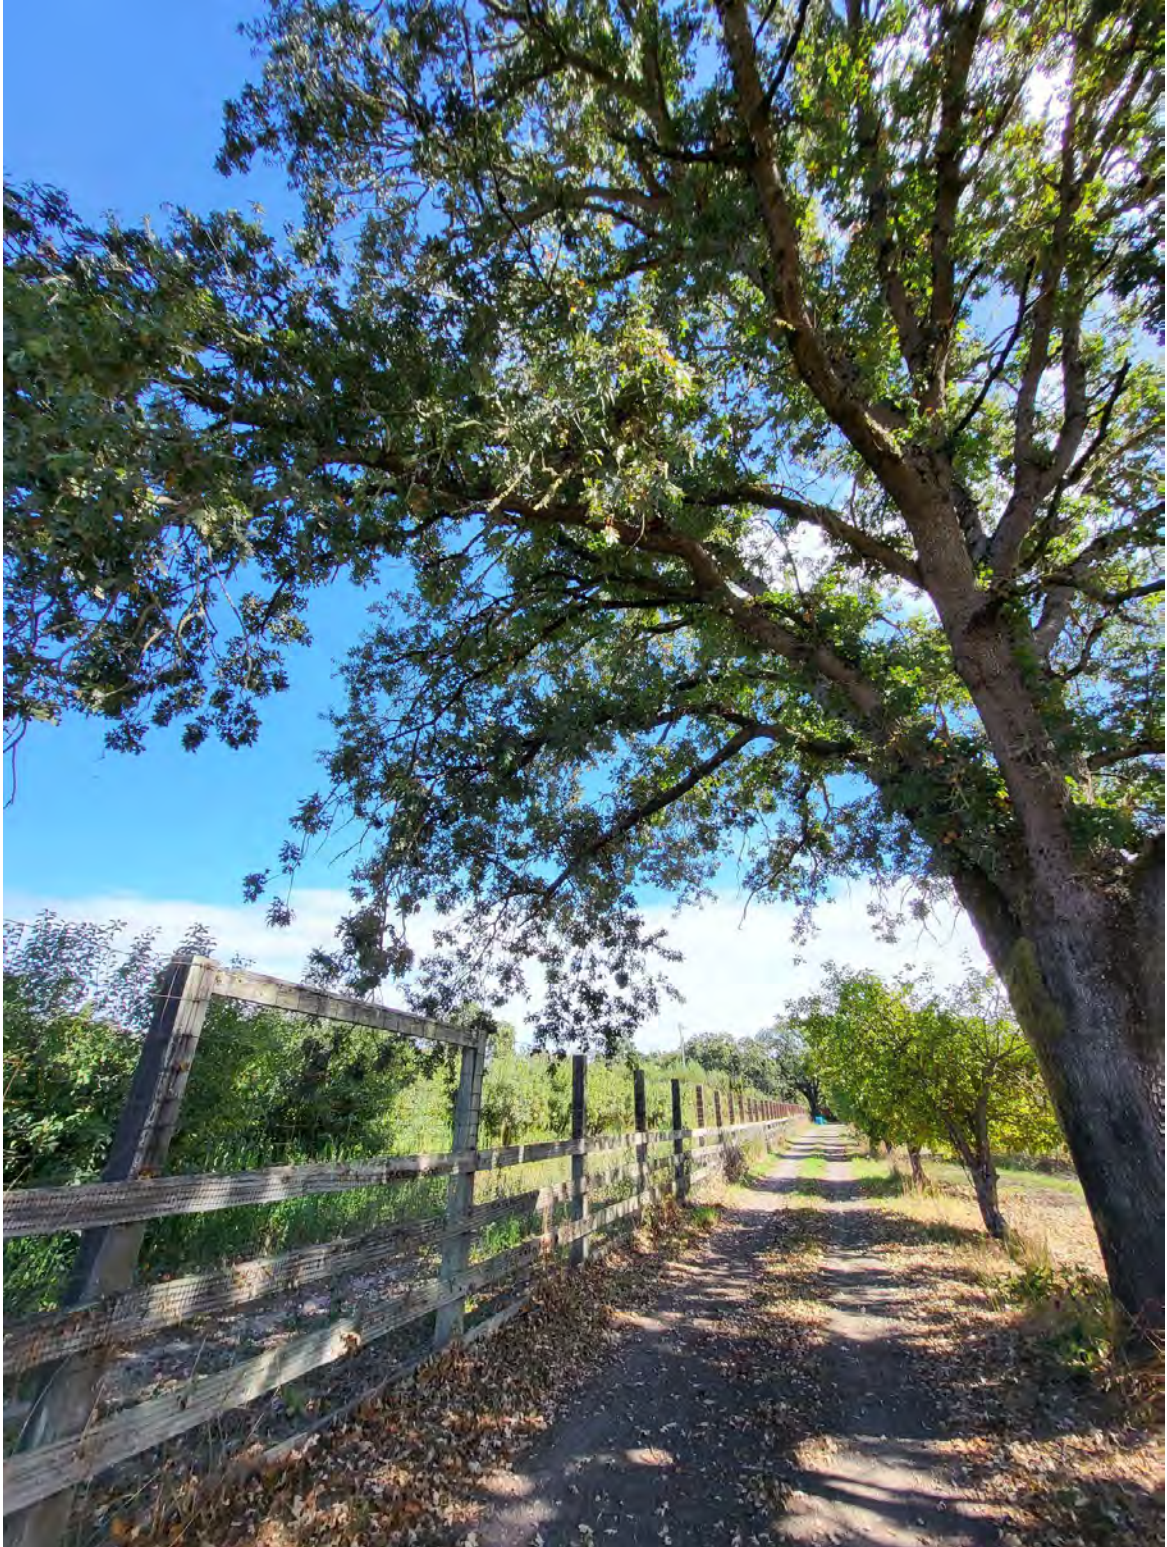
Photo 2. Oak tree will need clearance pruning over the driveway.

The design plans show the seventeen (17) assessed apple trees, and approximately twelve (12) willow stems within the stand, within the limits of disturbance of the planned project and removal will be necessary. The access road will be widened up to the dripline of the valley oak tree and as site upgrades are occurring near the Tree Protection Zone, tree protection measures will be necessary to preserve this tree. Impacts to the oak tree are expected to be low to none. Tree protection fencing should be installed at or beyond the dripline of the oak and the remaining willow and apple trees adjacent to the project area. Any excavation within the TPZ of the oak tree should be done by hand and supervised by a Certified Arborist. Pruning of lower branches for clearance will be necessary to provide equipment access. Any necessary pruning shall follow ANSI A300 standards, with no more than 20% of the live canopy removed.

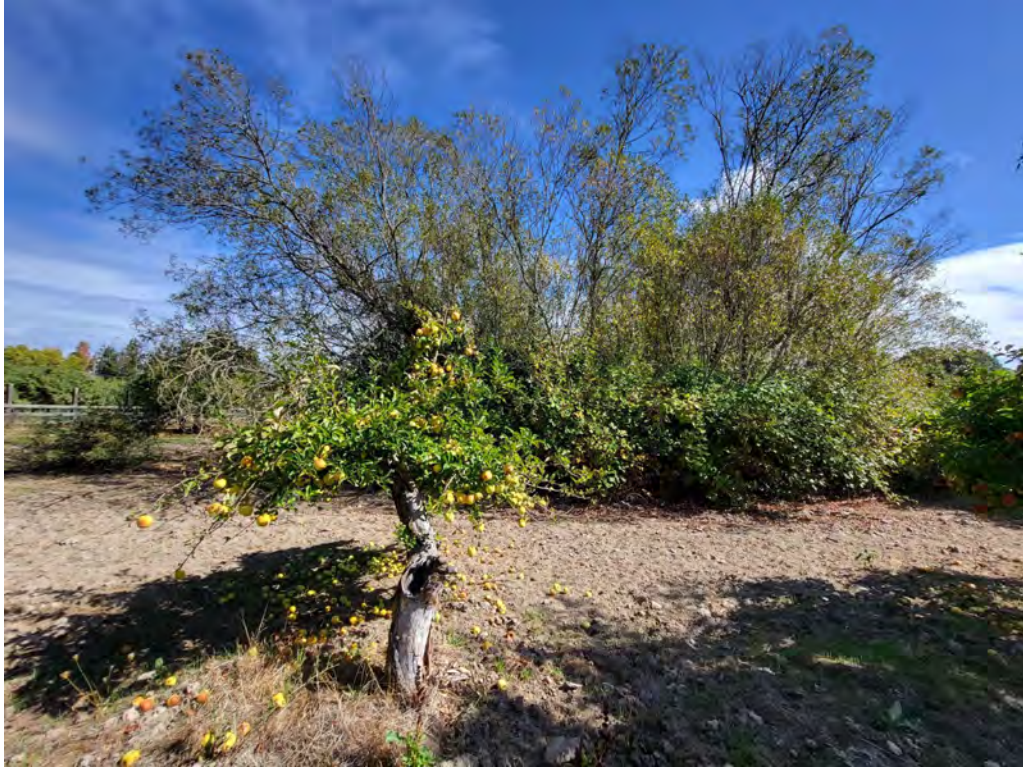
Photo 3. Stand of arroyo willows surrounded by blackberries. Apple tree in foreground.

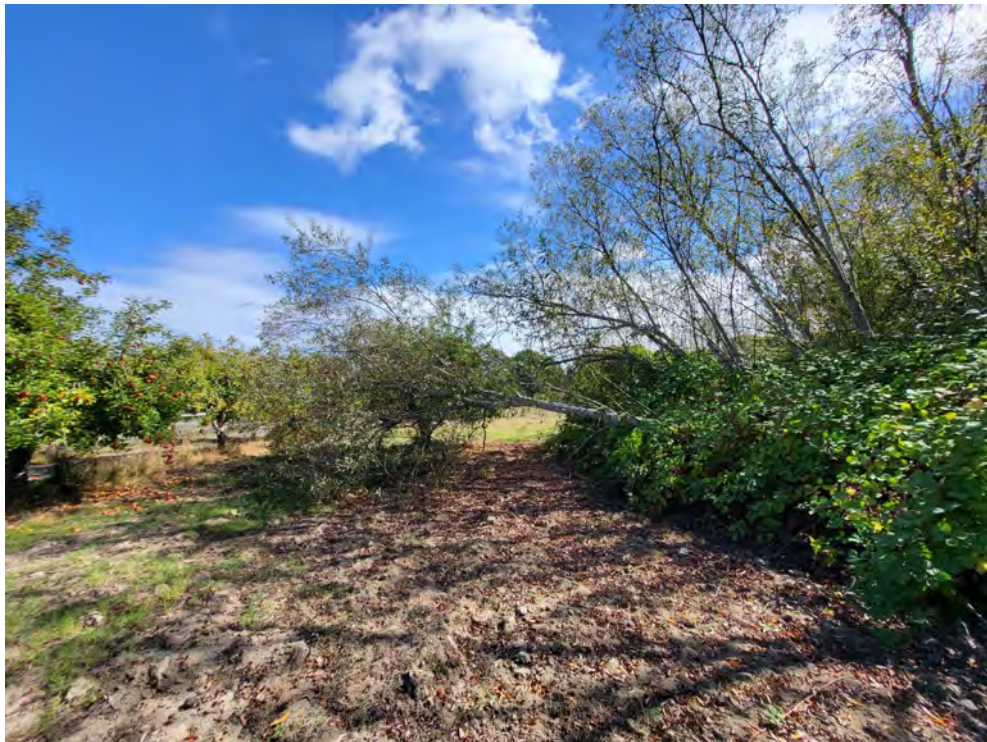
Photo 4. Edge of willow stand. Leaning willow, planned for removal has a trunk DBH of 7".

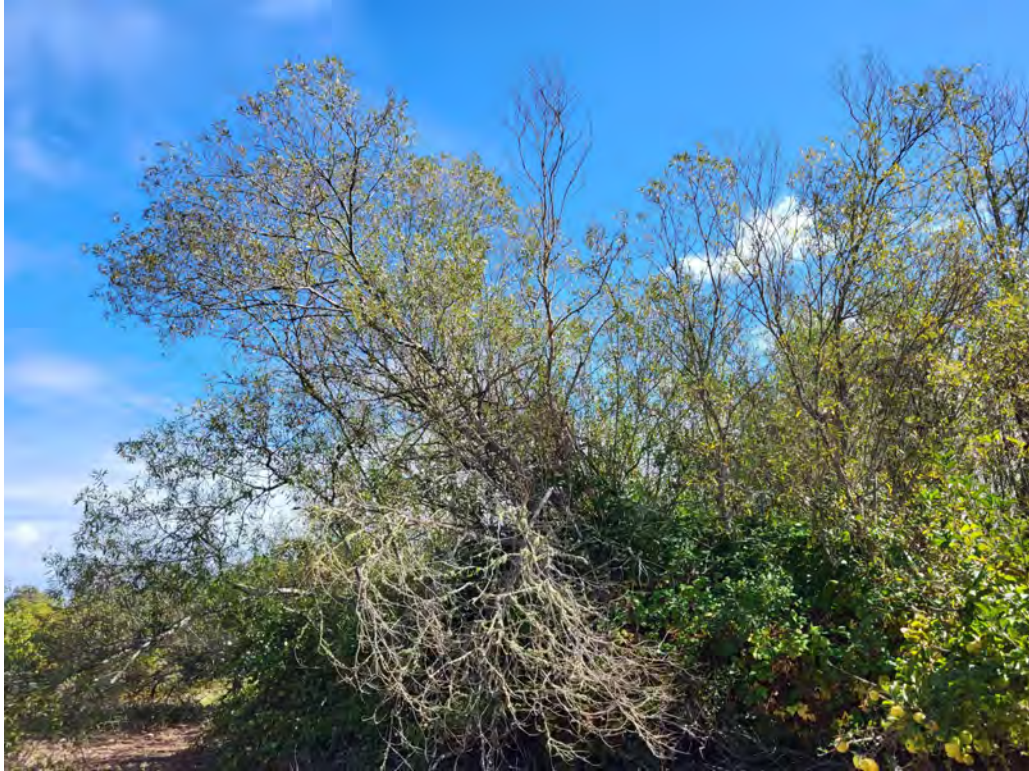
Photo 5. Approximately 12 willow stems are planned for removal for site development.

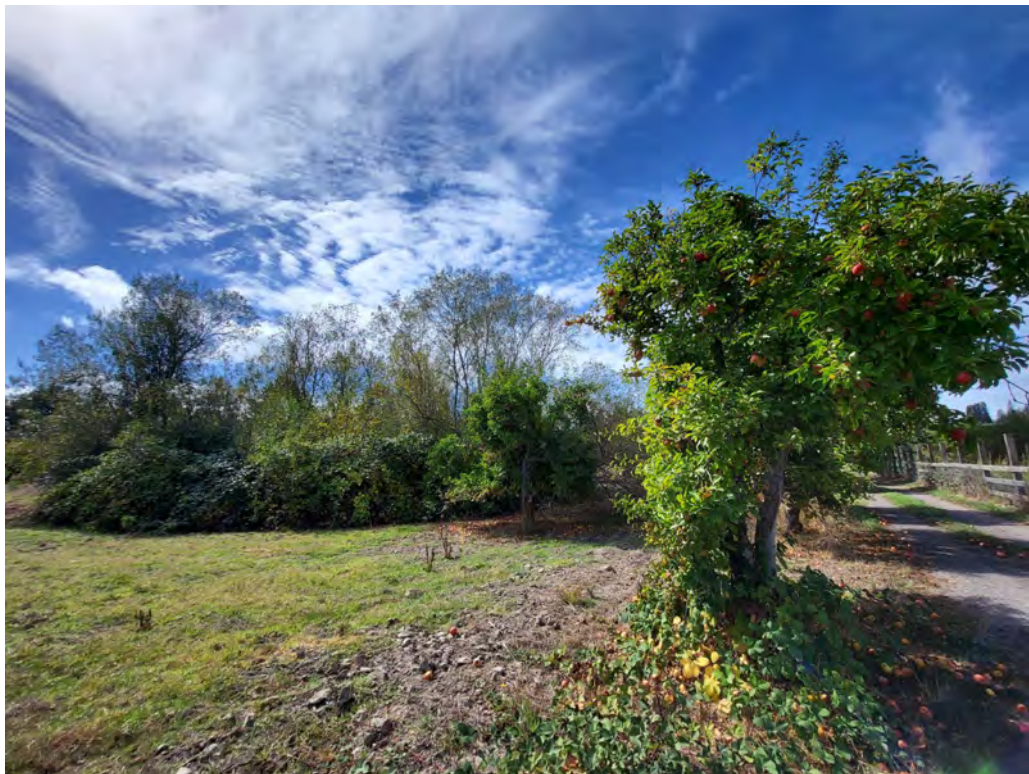
Photo 6. Eastern view of willows (center) and row of apple trees next to driveway (right).

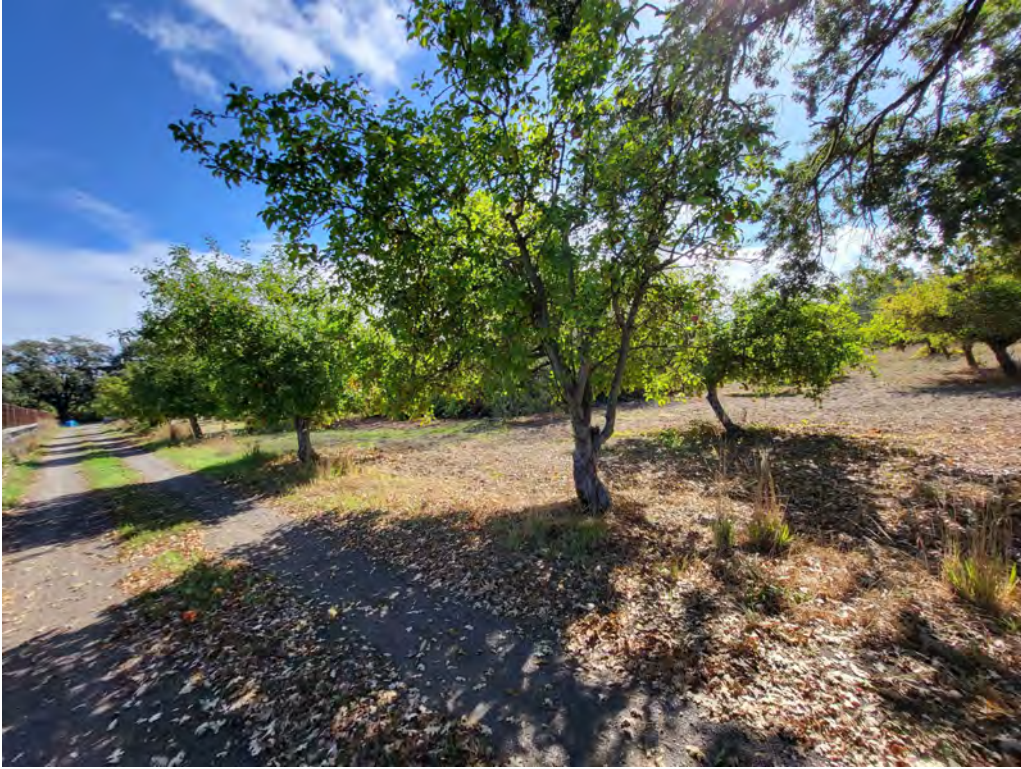
Photo 7. Apple trees line the driveway.
