Bridge Number : 20C0248
Facility Carried: LAMBERT BRIDGE RD
Location : 0.4 MI W OF DRY CREEK RD
City :
Inspection Date : 07/24/2017

Bridge Inspection Report

STRUCTURE NAME: DRY CREEK

Structure Description: Through steel pinned Parker Truss with RC deck on RC seat abutments
with monolithic wingwalls on spread footings

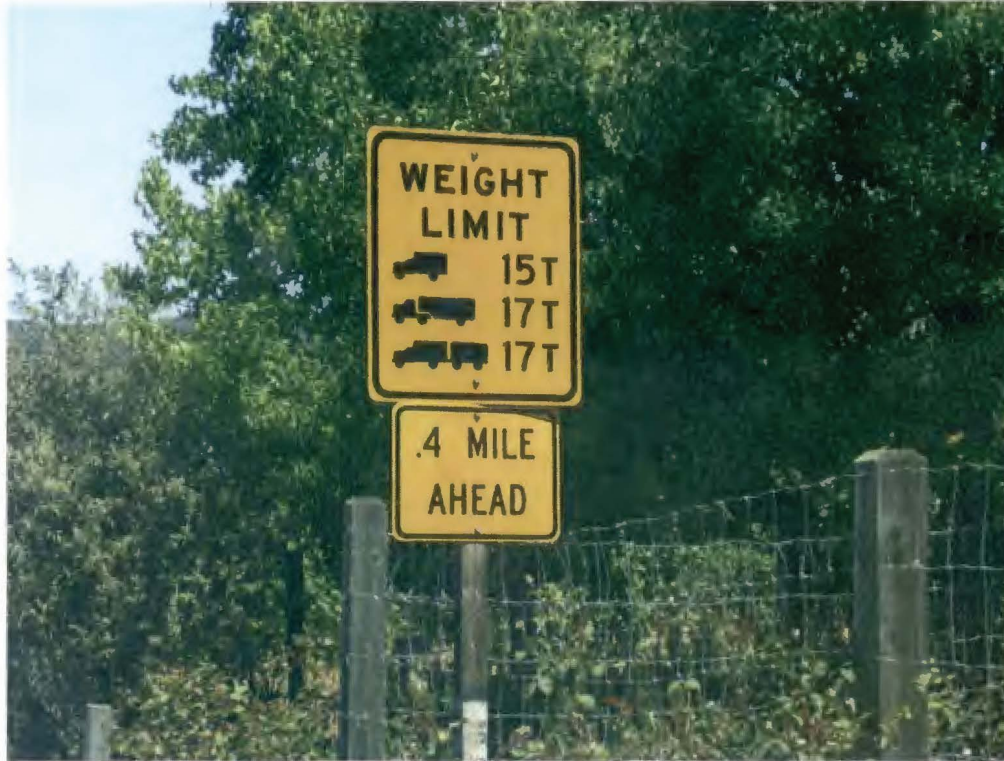
Photo No. 1

As seen in Photos #1 and #2, signs stating the load limitations of this structure are present at both approaches to the bridge:

Load Limit Sign- Advance Warning

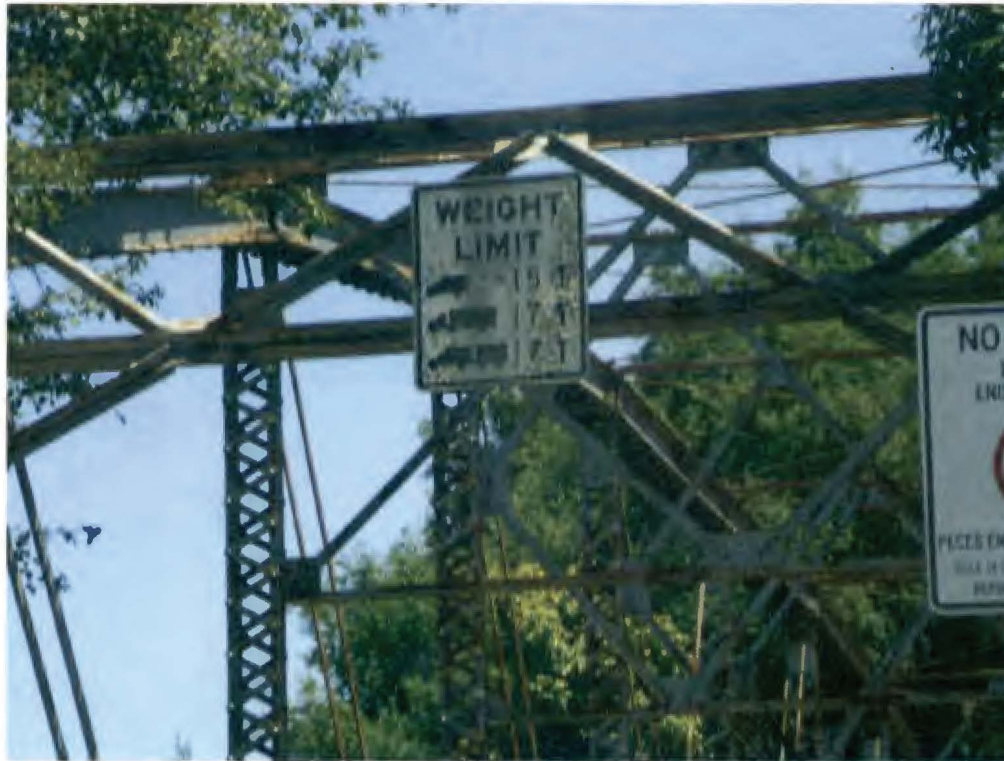
Photo No. 2

Load Limit Sign- On Bridge

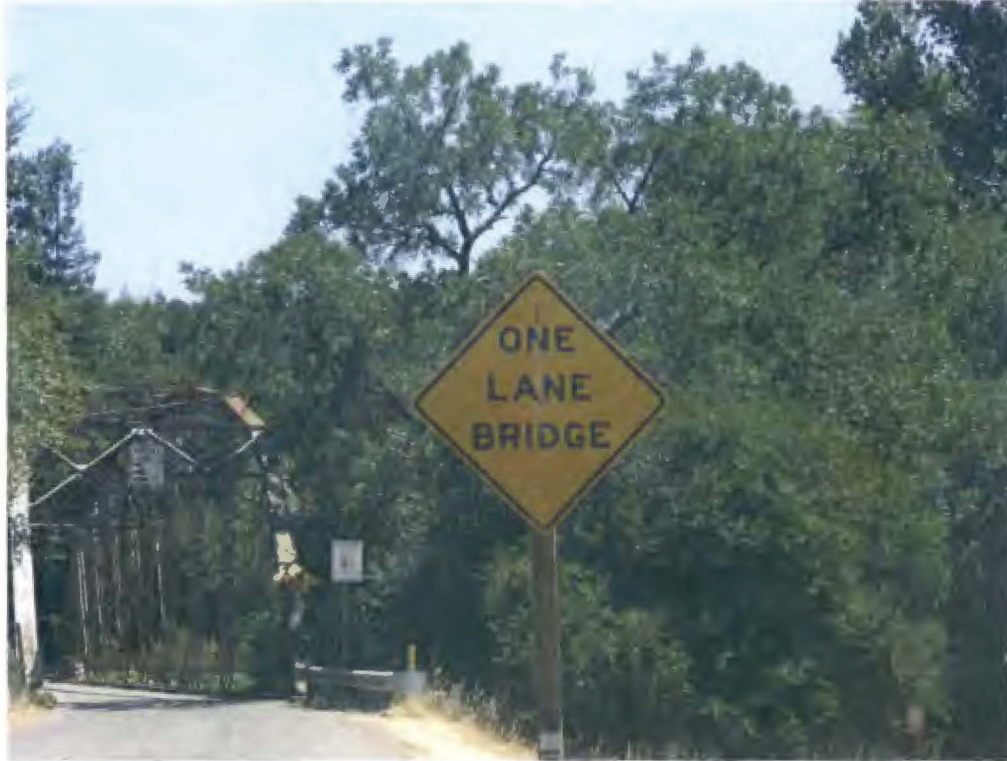
Photo No. 3

Signs Reading, "ONE LANE BRIDGE" were also present. See Photo #3.

'One Lane Bridge' Sign

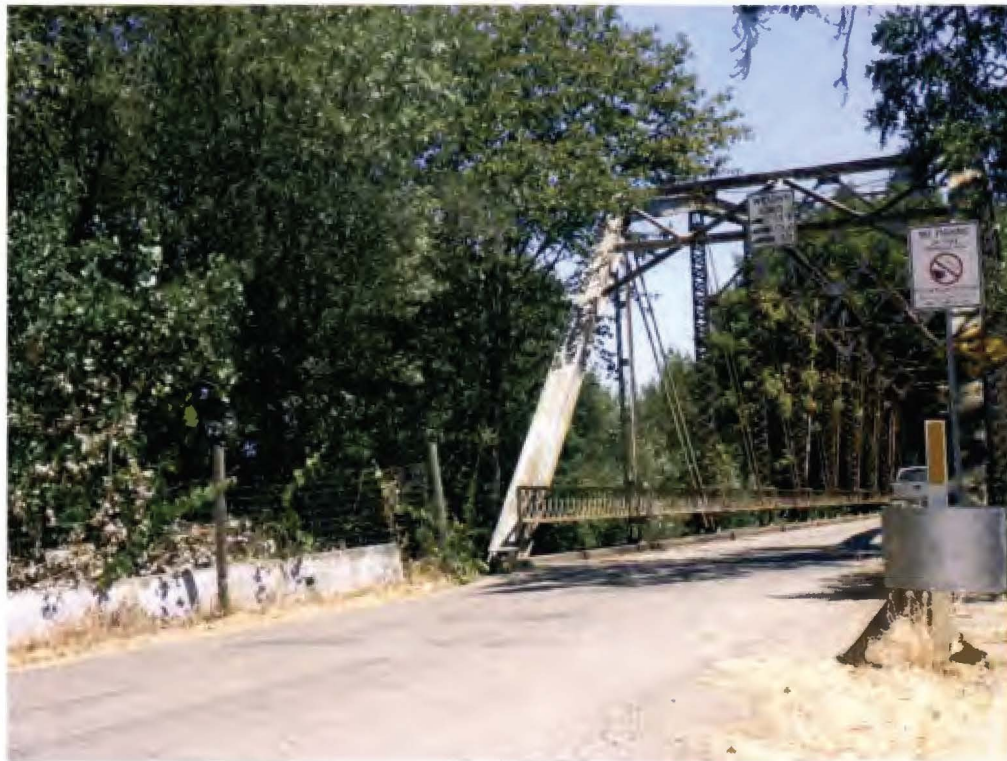
Photo No. 4

This bridge lacks an approach rail at the northwest corner. An approach rail would protect the end post of the bridge railing and the truss. See work recommendation dated 06/27/2001 and Photo #4.

Missing Approach Rail- Northwest Corner

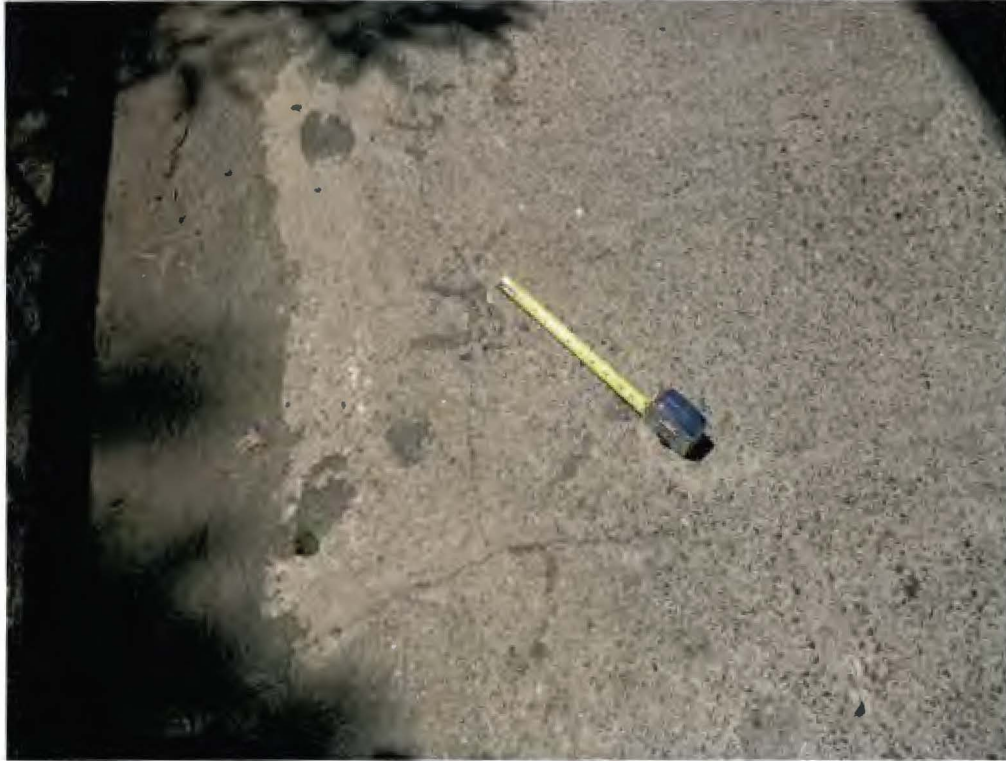
Elem No.	Defect /Prot	Element Description	Env	Total Qty	Units	Qty in each Condition	State
						St. 1 St. 2 St. 3 St. 4	
12		Deck-RC	2	302	sq.m	205 0 97 0	
	1130	Cracking (RC and Other)	2	97		0 0 97 0	
(12-1130)							
The deck exhibits severe size (0.09 inches wide) longitudinal and transverse cracks at 3 feet on center throughout, reflected by 0.04 inch wide soffit cracking without efflorescence. See Photo #5. A work recommendation to treat the deck with methacrylate was entered in 2015.							
113		Stringer-Steel	2	347	m	0 347 0 0	
	1000	Corrosion	2	347		0 347 0 0	
	515	Steel Coating-Paint	2	406	sq.m	0 0 406 0	
	3440	Effectiveness (Steel PC)	2	406		0 0 406 0

Photo No. 5
Deck Cracking (typ)

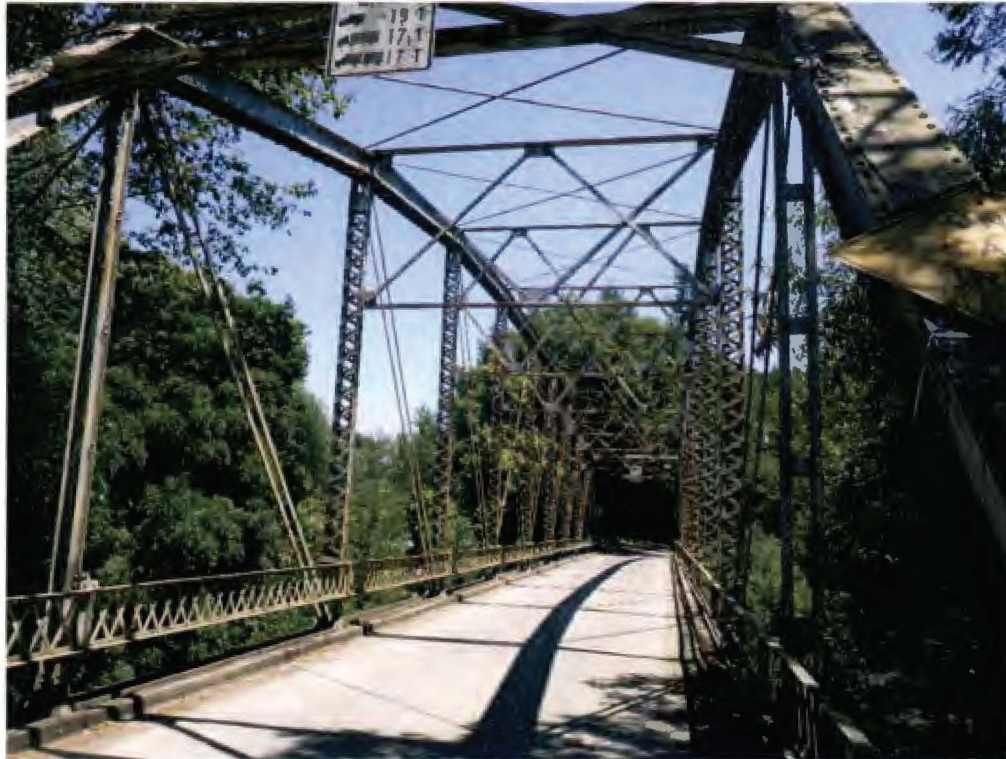
Surface rust is present on all structural members. See Photo #6.

Significant pack rust and section loss was observed at several of the lower chord panel points between the vertical gusset plates and the horizontal and diagonal eye-bars. No significant section loss was observed in the diagonal or horizontal eye-bars at this time. See the main text section of this report for a detailed account of pack rust on the truss members.

The paint system on this structure has largely failed. See Photo #6. A work recommendation to clean and repaint all superstructure elements was entered in 2000.

Photo No. 6
Truss Condition

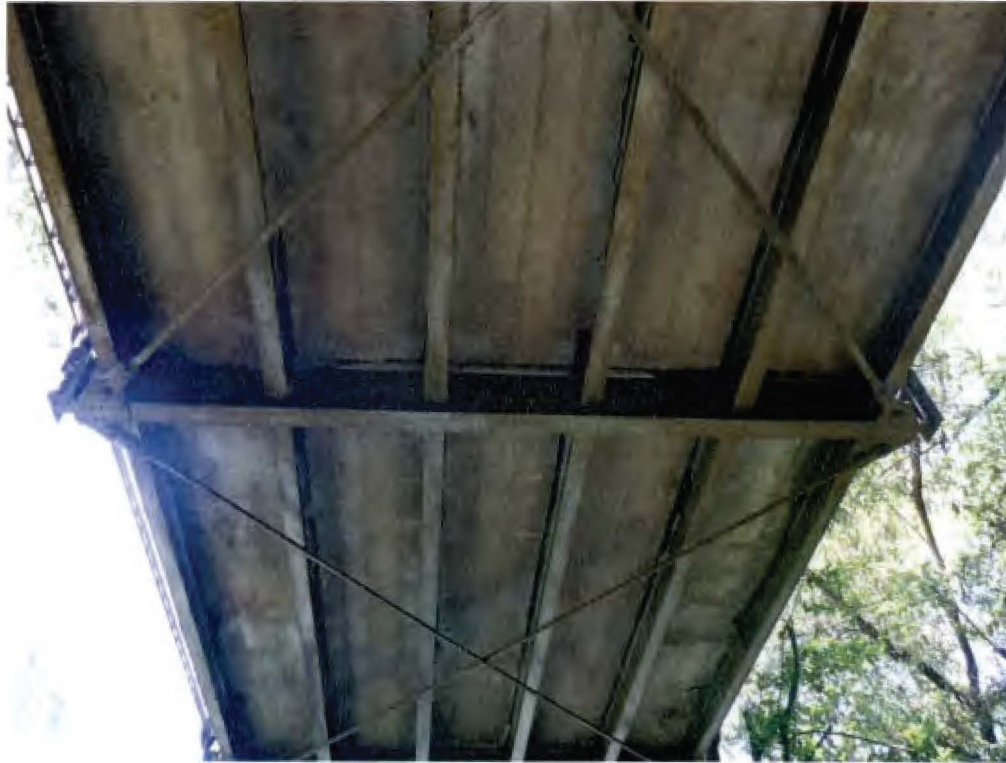
Photo No. 7

Surface rust is present on all structural members. See Photo #7.

The paint system on this structure has largely failed. See Photo #7. A work recommendation to clean

The paint system on this structure has largely failed. See Photo #7. A work recommendation to clean and repaint all superstructure elements was entered in 2000.

Floorbeam and Stringer Condition (typ)

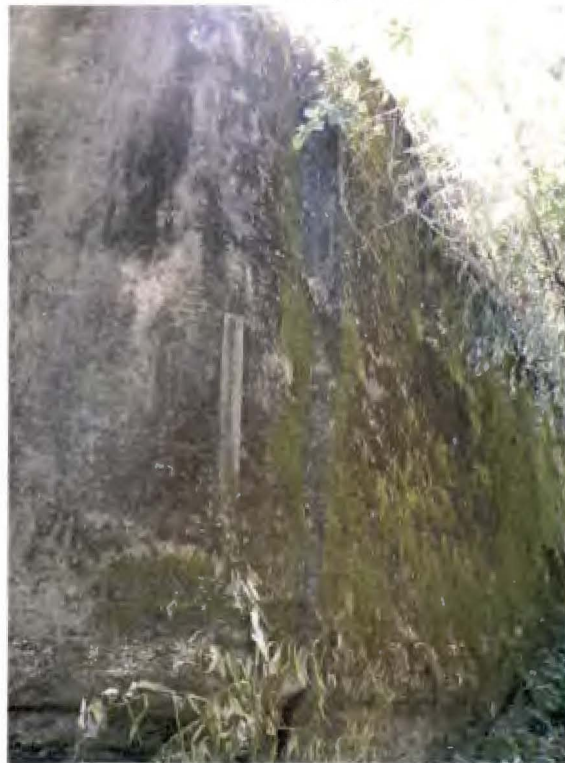
Photo No. 8

Elem No.	Defect /Prot	Element Description	Env	Total Qty	Units	Qty in each Condition State			
						St. 1	St. 2	St. 3	St. 4
similar condition. See work recommendation dated 08/03/2000 and archived photos dated 2009 and 2011.									
215		Abutment-RC	2	23	m	21	2	0	0
	1130	Cracking (RC and Other)	2	2		0	2	0	0
(215-1130)									
The left wingwall of Abutment 1 has cracked and separated from the breastwall and is leaning outward by approximately 18 inches, measured at the top of the wall. See Photo #8. Glen Wallis, Bridge Maintenance Engineer of Sonoma County, stated that this wingwall has been anchored to a new deadman and waler system (work completed in 2002).									
220		Pile Cap/Footing-RC	2	4	m	0	4	0	0
	6000	Scour	2	4		0	4	0	0
(220-6000)									
The left (upstream) half of the footing at Abutment 1 is vertically exposed by up to 28 inches with minor undermining at the upstream corner of up 4 inches vertically and 8 inches horizontally. See Photo #9. A preliminary scour investigation conducted by the Caltrans SMI Hydraulic Branch in August 2013 found that the footing is founded on soft rock. Corrective action is not warranted at this time, however this condition should be monitored during future inspections.

Abutment 1, Left Wingwall Condition

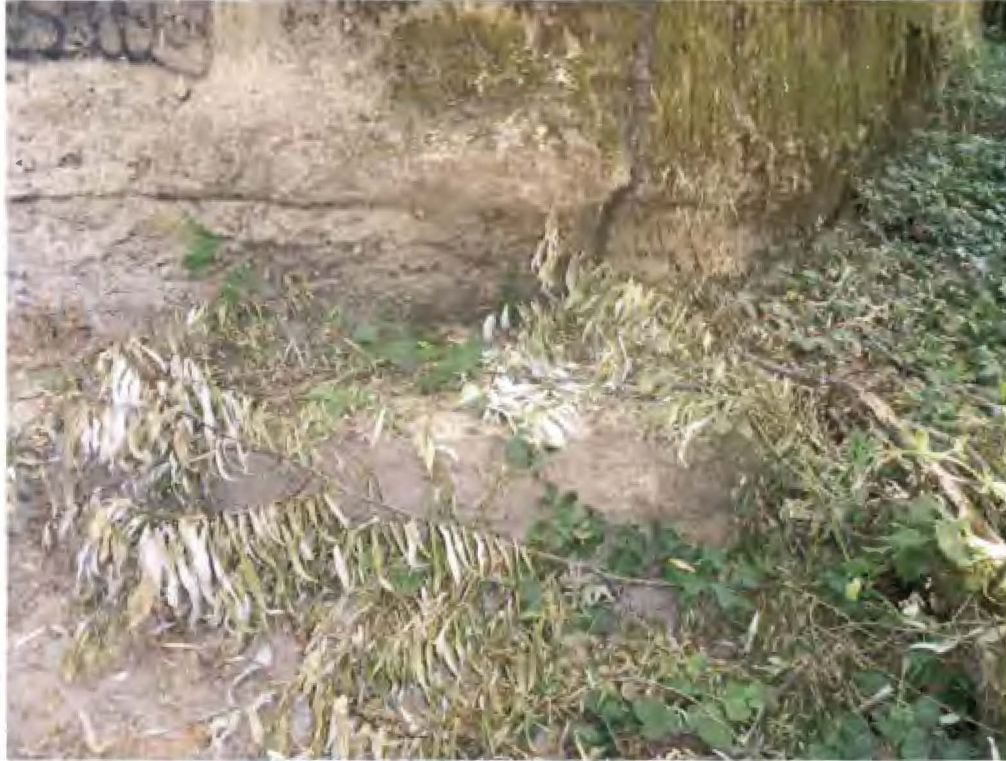
Photo No. 9

Abutment 1 Left Side Footing Exposure
