Re: Proposed Cannabis Permit, UPC18-046, 6699 Palmer Creek Road, Healdsburg

Subject: Review of Initial Study/Mitigated Negative Declaration SCH No. 2021040407 Evergreen Acres, LLC (UPC18-00046)

Evergreen Acres LLC March 11, 2022 Inspection CIWQS Place ID. 847681

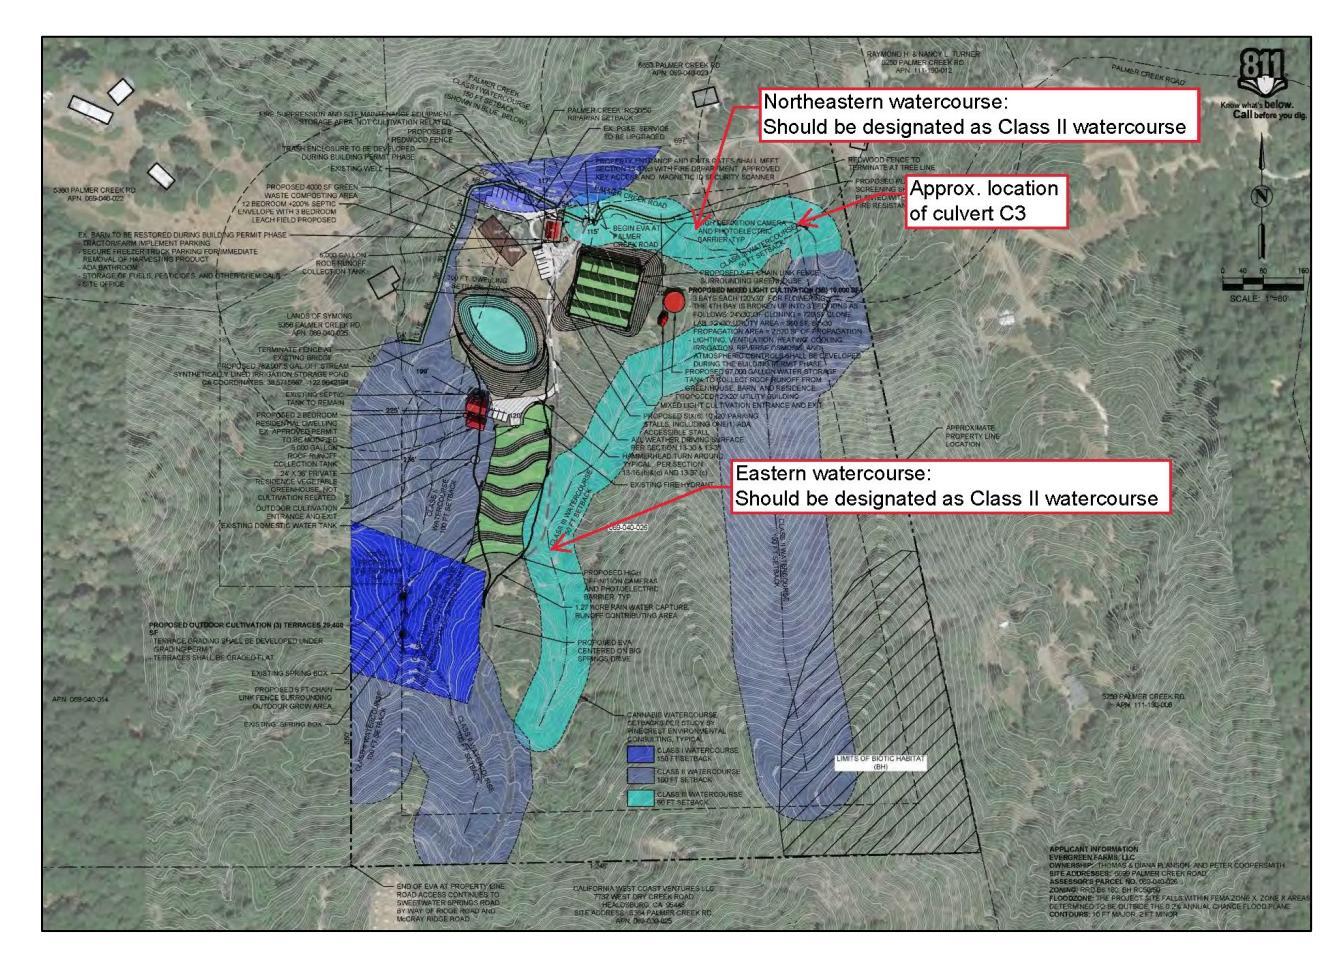
FIGURE 1: Project Site Plan (modified from Figure 3 of IS/MND).

the Northeastern watercourse draining to culvert C3² as a Class II watercourse. The locations of culvert C3 and the Northeastern watercourse are indicated on Figure 1. Correcting the Northeastern watercourse designation to a Class II watercourse requires that the riparian setback be increased from 50- to 100-feet, as discussed below in Section 1.3. This change will also necessitate reevaluating impacts and design of the mixed light cultivation area and other infrastructure, which fall within a 100-foot Northeastern watercourse riparian setback.

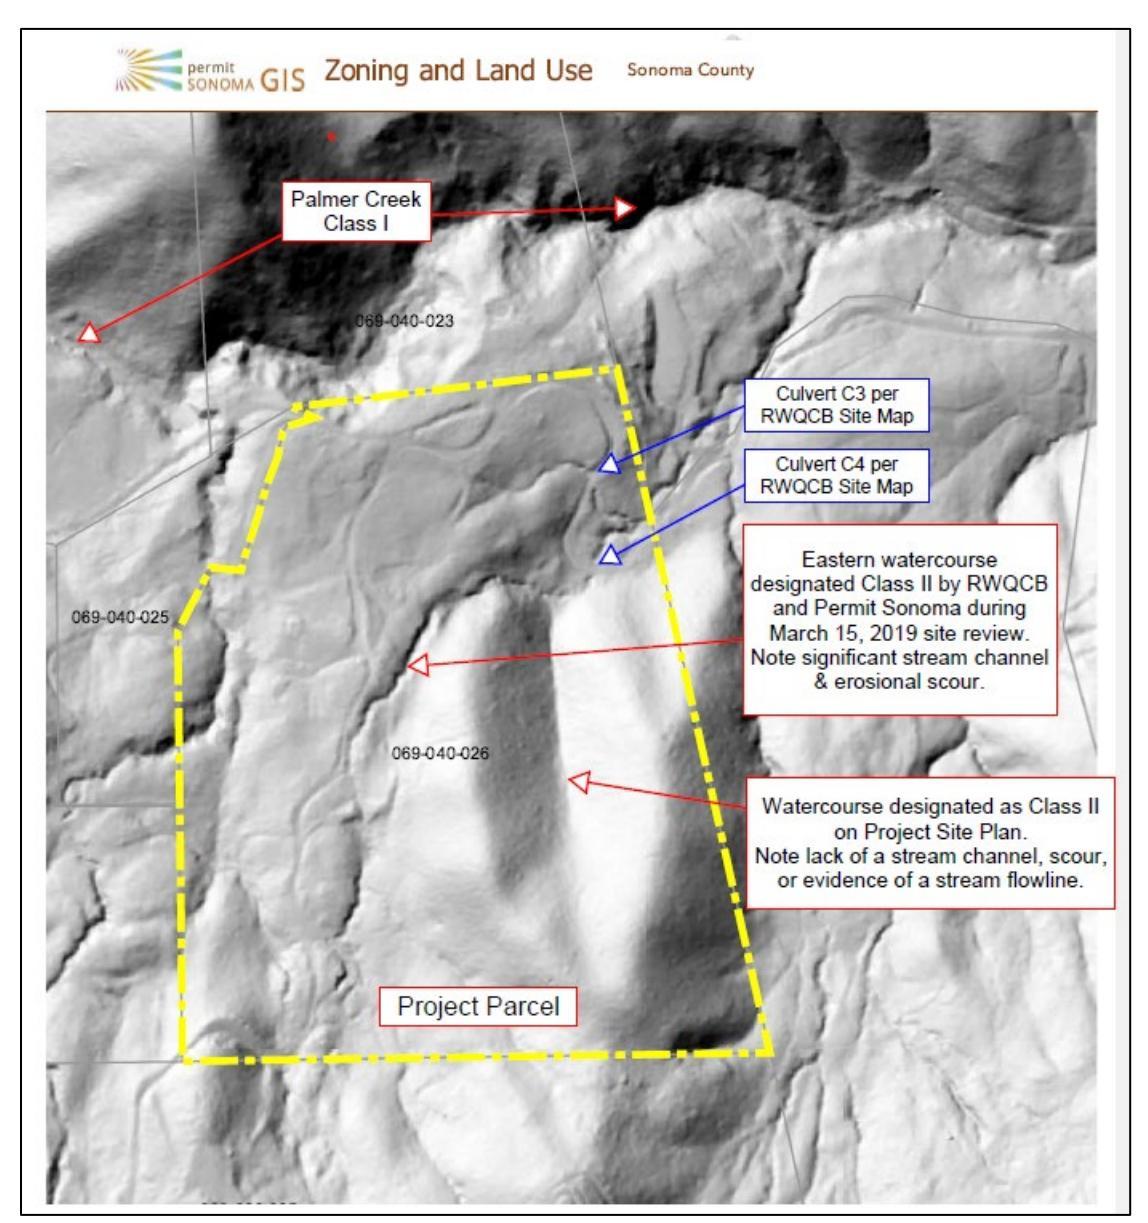
FIGURE 2: Permit Sonoma LiDAR imagery of Project site.

As seen in the LIDAR imagery as provided through the Permit Sonoma ActiveMap GIS website (Figure 2), and as used by Robert Pennington for his initial watercourse classifications, the Eastern watercourse channel clearly exhibits the *"significant surface flow, bed and banks, and morphology*"

consistent with Class II channels" that was confirmed in Mr. Pennington's March 15, 2019, site inspection and as stated in his subsequent findings.

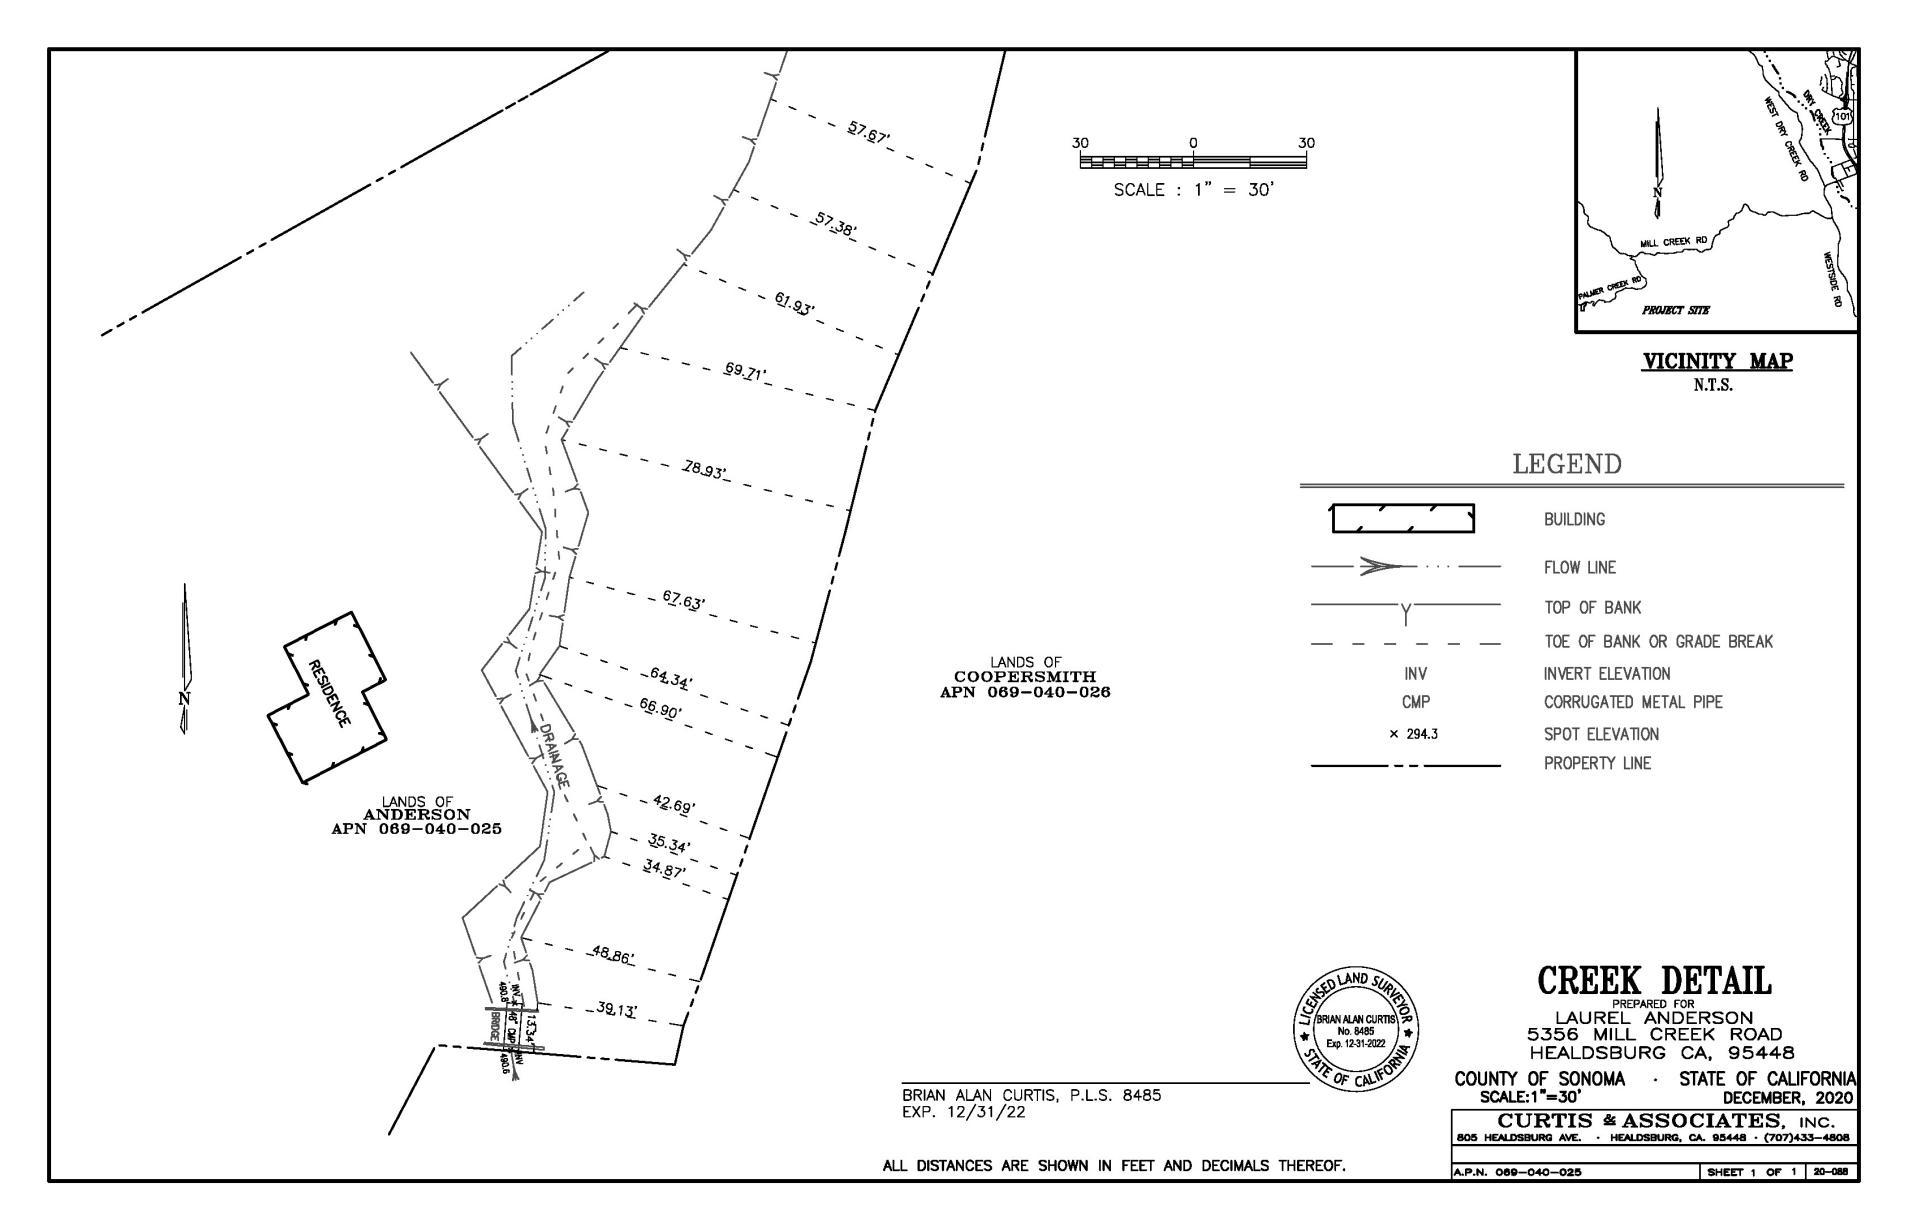
FIGURE 3: Survey of creek details on Western watercourse (Curtis & Associates, 2020)

Based on my review, it appears that the riparian setback zones mapped on Project plans and IS/MND figures are measured from the centerline of creek alignments, not from the bankfull stage line or top of bank alignment. Thus, the riparian setback zones are narrower than if delineated using the bankfull stage line or top of bank. An example of the difference between the relative position of the creek centerline versus top of bank alignment is provided in the December 18, 2020, survey of the Western watercourse by Curtis Engineering (Figure 3). This survey maps the creek flow/center line and top of bank alignments along the Western watercourse immediately west of the proposed reservoir and outside of the Project area. It provides an example of the topographic information (i.e., delineation of top of bank) necessary to establish proper riparian setbacks. It also demonstrates that riparian setbacks would extend further from the creek centerline if the top of bank alignment is used as the setback reference point. Whether determined by ground survey or LiDAR maps, an accurate delineation of creek channel top of bank was not presented in the IS/MND for watercourses within the Project area as required to delineate riparian setbacks. If mapped correctly within the Project area, the riparian setbacks would extend further from the creek centerline and impinge on the proposed cultivation areas and possibly other proposed infrastructure, requiring these project elements be reduced in size or relocated. Therefore, the IS/MND does not accurately map riparian setbacks, which is necessary to fully identify potential project impacts within the riparian setbacks.

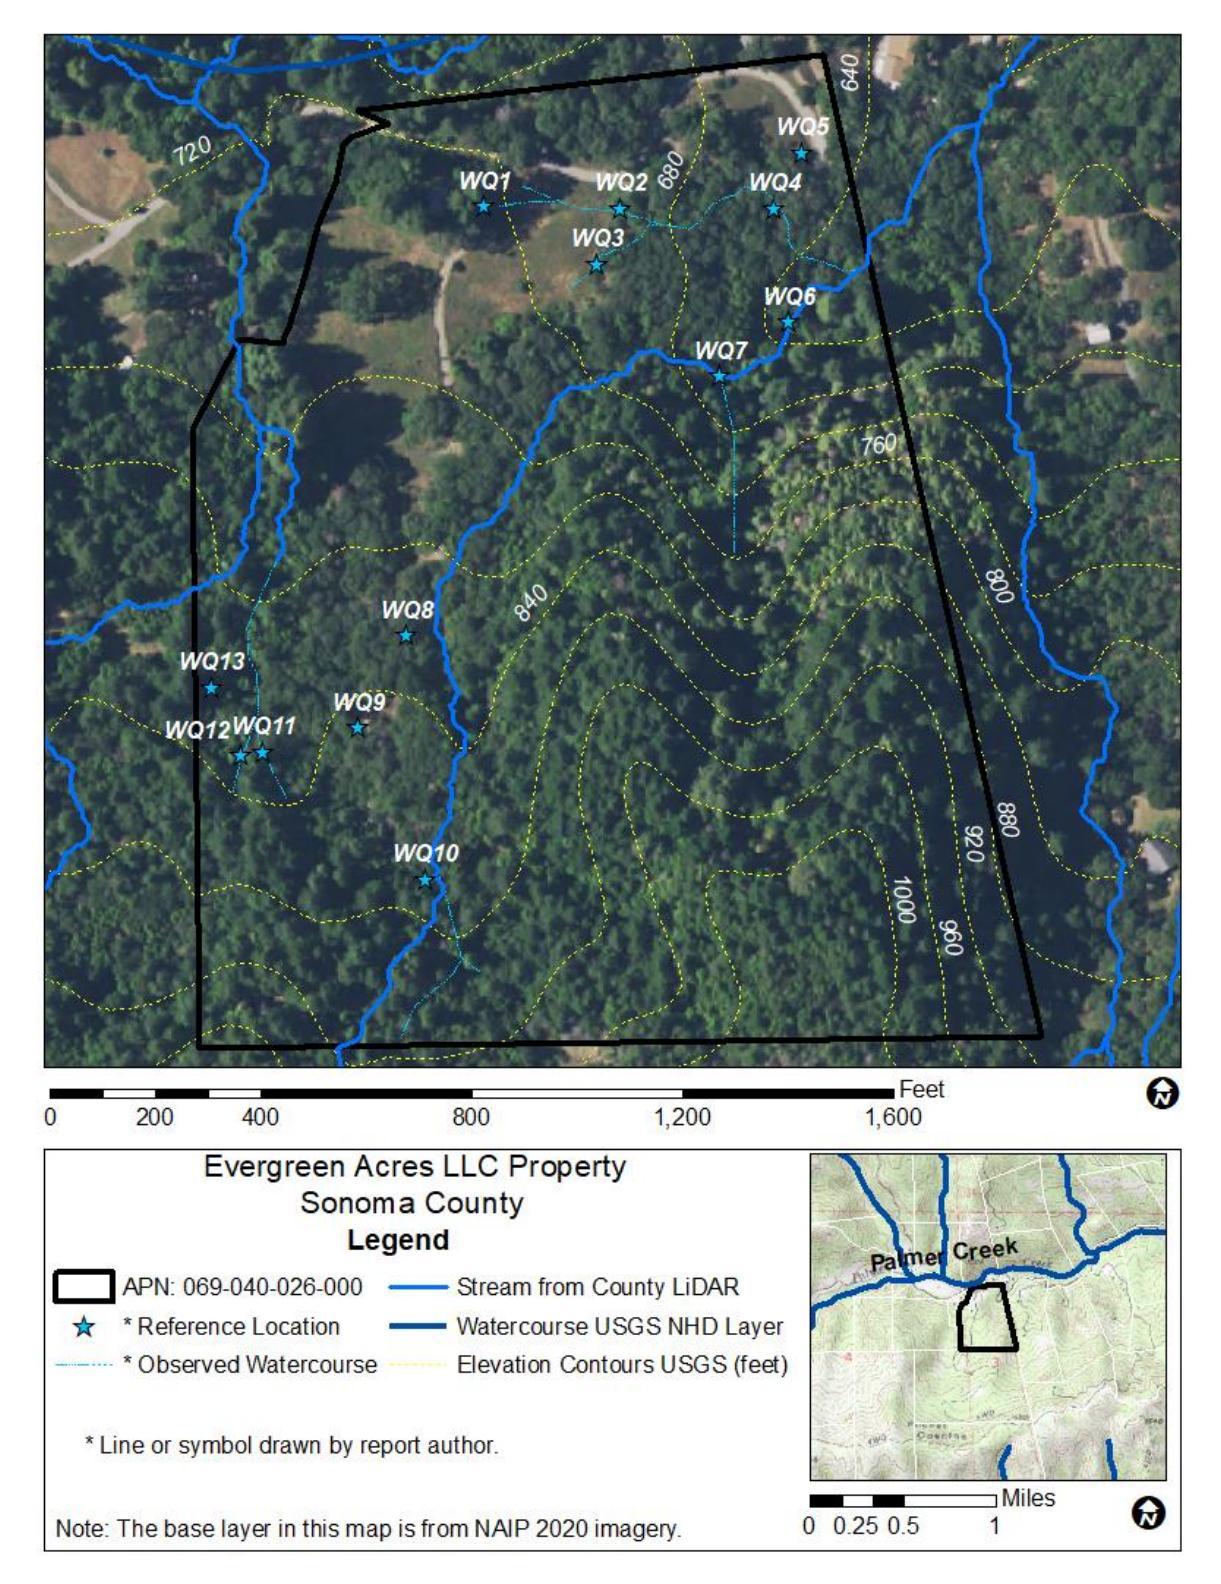
Figure 1: Aerial image/map showing inspection points discussed in this report.

The Inspection Map (Figure 1) shows reference locations discussed in this report. Reference marker locations are approximate and intended to assist the reader with locating features identified in the Inspection Narrative below and the Photo Appendix that appears at the end of this document. The map includes watercourse layers from the United States Geological Survey (USGS) National Hydrography Dataset,¹ the Sonoma County 2013 LiDAR Dataset,² and a layer containing watercourse segments directly observed by Staff during the inspection that were not displayed in the other data sets. Staff did not directly observe all watercourses displayed on the Inspection Map, nor did they conduct a comprehensive delineation of all watercourses on the Property. Instead, Staff focused their inspection on watercourses whose classifications appeared to be in dispute, based on previous reports and other exhibits available in Permit Sonoma's administrative record.

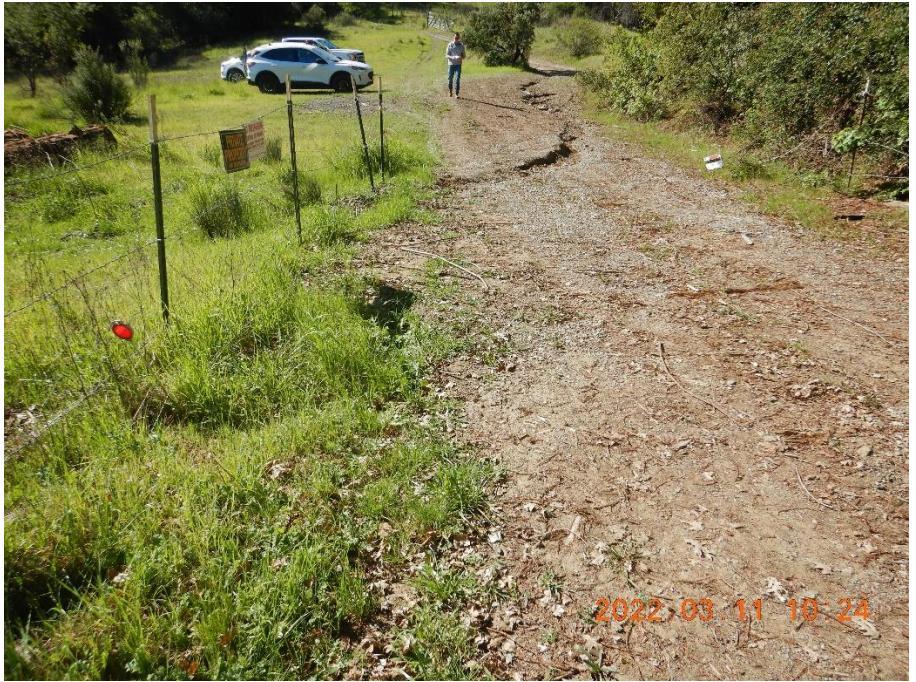
I observed that a rill had formed on the access driveway at WQ1 (Photo 1). I followed the rill downslope and to the east where I observed intermittent scour marks (Photo 2) and sorted sediment (Photo 3), which are indicative of erosion and sediment movement by flowing water. This Class III watercourse³ continues to the east. In the vicinity of WQ2 (Photo 4), the watercourse transitions into a Class II where the channel steepens, increases in depth and width, and displays a distinct bed and bank with a step-pool morphology – which serves as habitat for aquatic macroinvertebrates.

Photo 1— Looking south toward WQ1 where a rill is visible on the road surface.

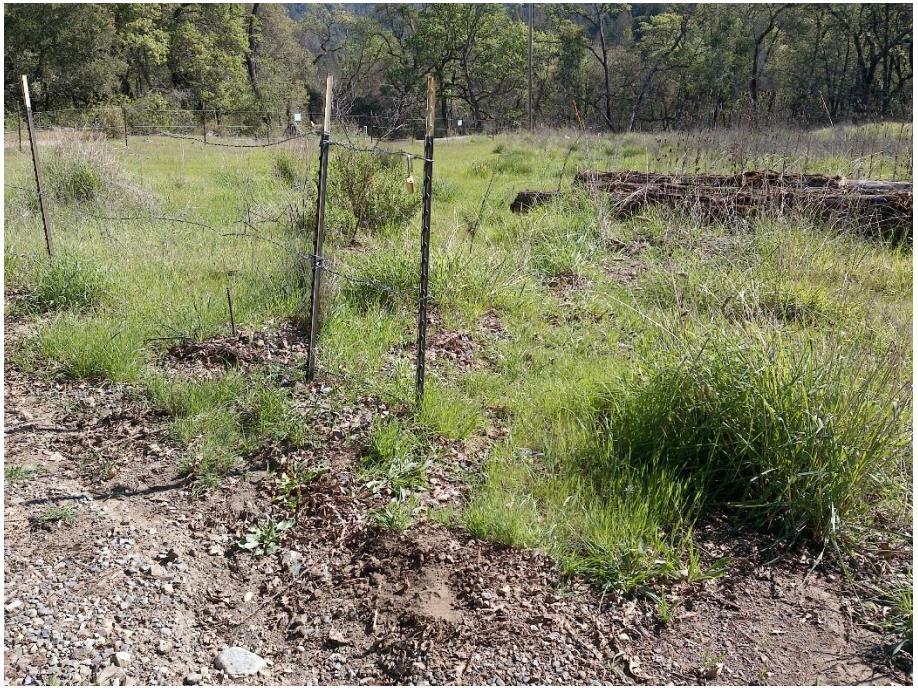
Photo 2— Looking east and downhill from WQ1. Intermittent scouring across the grassy area marks the flow path of a Class III watercourse.

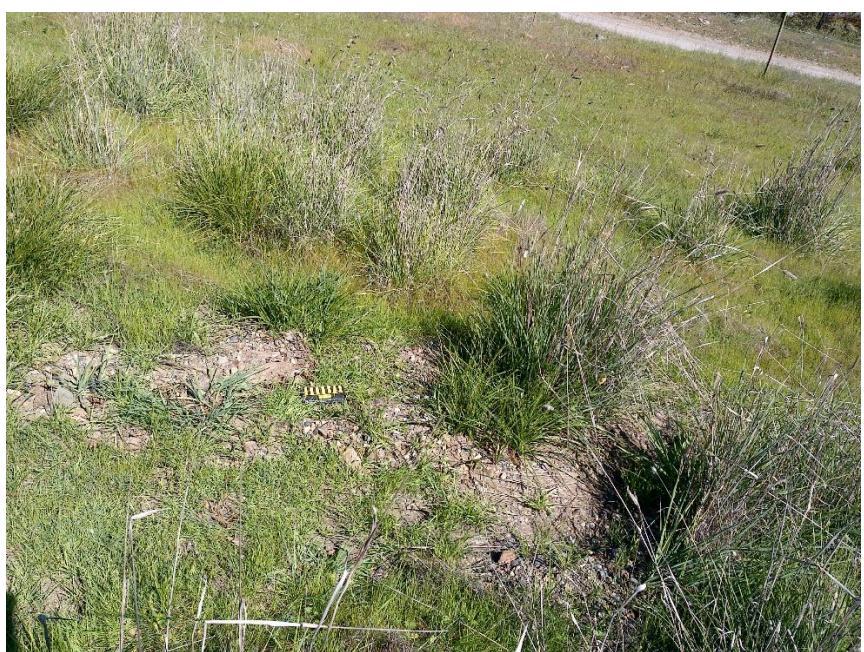
Photo 3— Scouring east of WQ1. A 15cm long black and yellow ruler is visible in the middle of the image and a lens of sorted gravel is visible in the lower right of the image.

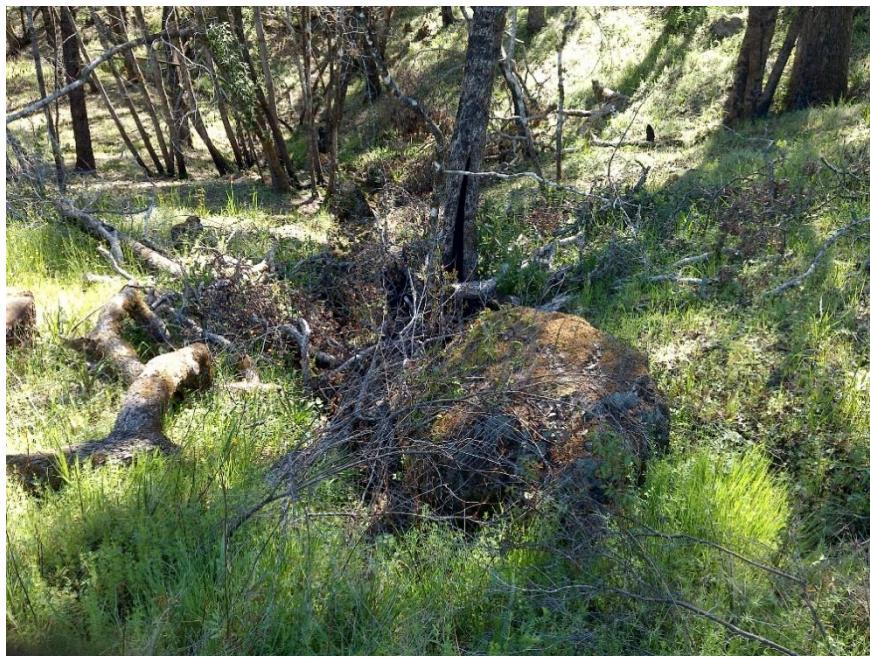
Photo 4— Looking east in the vicinity of WQ2. The intermittent ephemeral (Class III) watercourse is to the back of the photographer. The flow path for the watercourse continues in front of the photographer where the channel topography steepens. Downslope from the boulder in the middle of the image, the watercourse becomes a Class II, with a clearly defined bed and bank, and habitat for aquatic macroinvertebrates.

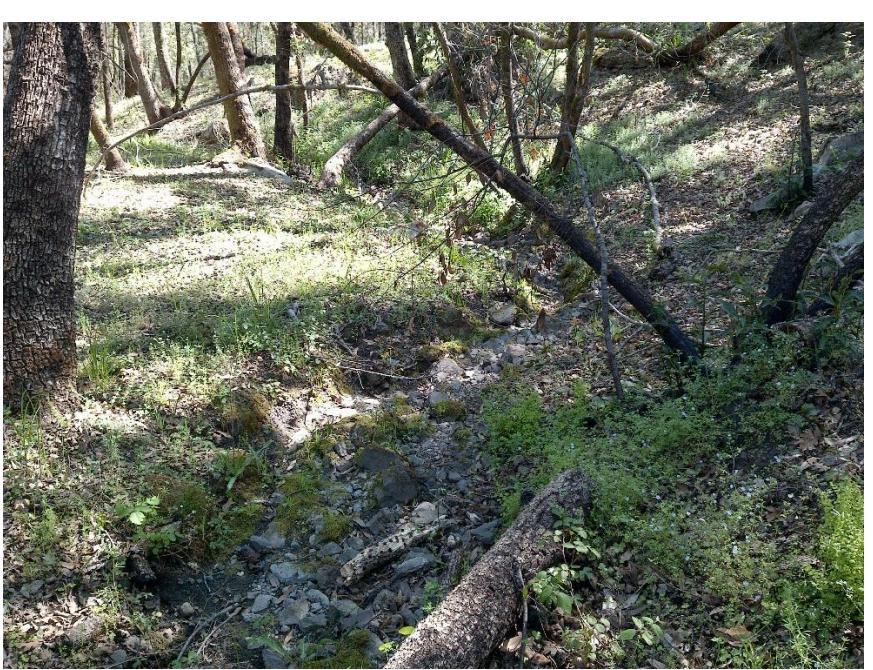
Farther downstream (Photo 5), the channel converges with another watercourse with similar morphology. I walked up this stream and observed a step-pool morphology with a trickle of water and observed coarse gravels in the pools that are habitat for aquatic

Photo 5— Looking east from where the Class II watercourses flowing downstream of WQ2 and WQ3 converge. The resulting Class II watercourse has a distinct cobble and gravel substrate and well-defined banks.

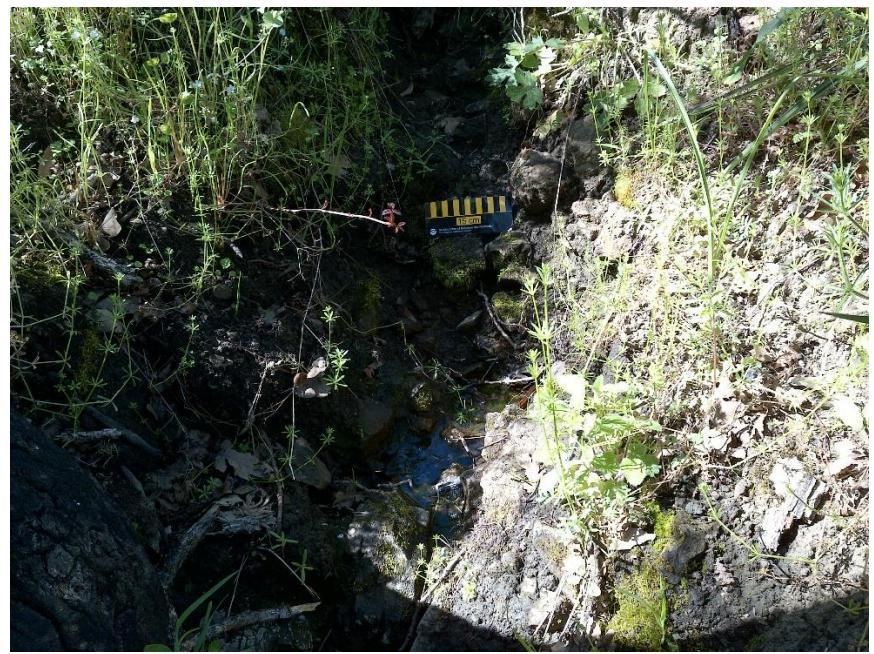
Photo 6— Small pool within a Class II watercourse immediately northeast of WQ3. A 15cm long black and yellow ruler is visible in the middle of the image and shows that the channel is between 30cm and 50cm wide. Water is visible in the pool.

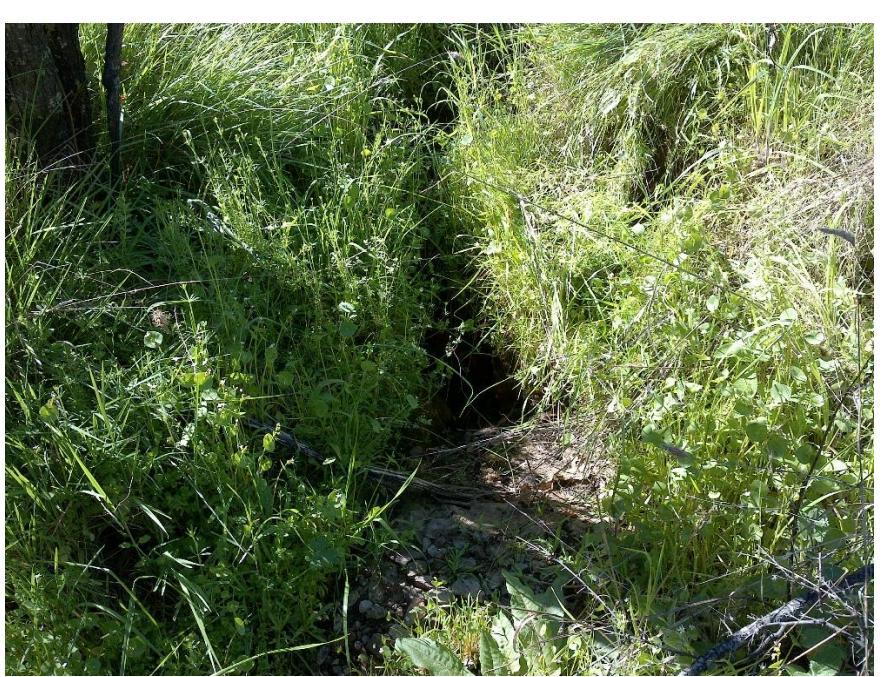
macroinvertebrates (Photo 6). I observed this habitat continued upstream to WQ3 (Photo 7). Southwest of WQ3 there is evidence of scour from flowing surface water, but I did not observe features that would provide unique habitat for aquatic macroinvertebrates, which suggests WQ3 is the approximate location of the transition from a Class III to a Class II watercourse.

Photo 7— Looking at watercourse in the vicinity of WQ3. Upstream and to the southwest of this location the watercourse bears Class III characteristics, such as intermittent scour marks. Downslope from this location the channel bears Class II characteristics, including a step-pool morphology that provides habitat to aquatic macroinvertebrates.

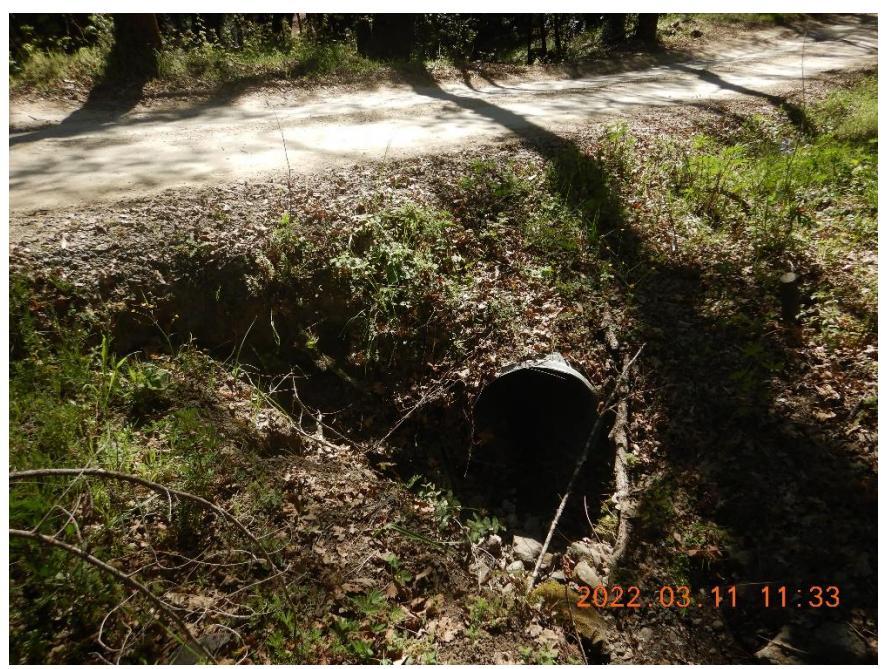
We then followed the combined Class II watercourse downstream to WQ4 (Photo 8), where I observed a culvert below the access road. I observed that the road to the north was hydrologically connected to the channel from WQ5 via a roadside ditch (Photo 9). I continued to follow the watercourse downstream to where it converged with another Class II watercourse and then walked up the converging watercourse and observed another culverted watercourse crossing at WQ6. This culvert inlet was adequately aligned with the channel's horizontal axis (Photo 10), but the culvert outlet was perched 3 feet above the receiving watercourse bed where I observed a scoured pool, and that the channel was locally wider (Photo 11).

Photo 8— Looking east at the inlet of a 24-inch diameter corrugated metal pipe (CMP) culvert at WQ4. A roadside ditch is entering the channel from the left of the image.

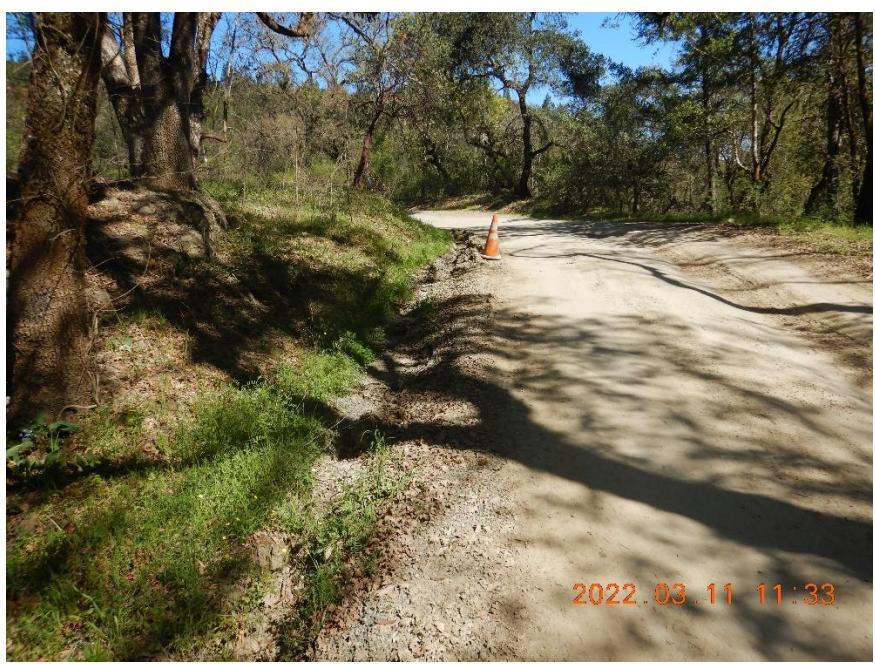
Photo 9— Looking northeast along roadside ditch that discharges to the watercourse in the previous image. The road is shaped such that stormwater will be directed into the roadside ditch. A rolling dip could be added across the road in the upper portion of the image, marked by an orange cone and by WQ5 on the Inspection Map. Installation of a rolling dip at this location would prevent road runoff from entering the watercourse.

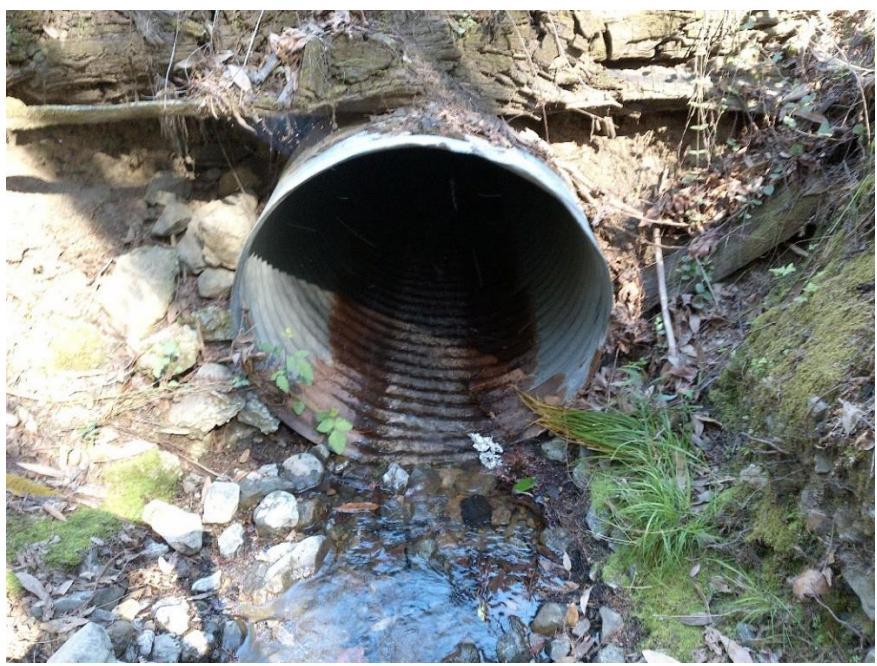
Photo 10— Looking northeast at the inlet for a 36-inch diameter CMP in the vicinity of WQ6. The earthen fill surrounding the culvert inlet has been scoured by stormwater and the rust line inside the culvert is approximately 25% above the culvert bottom.

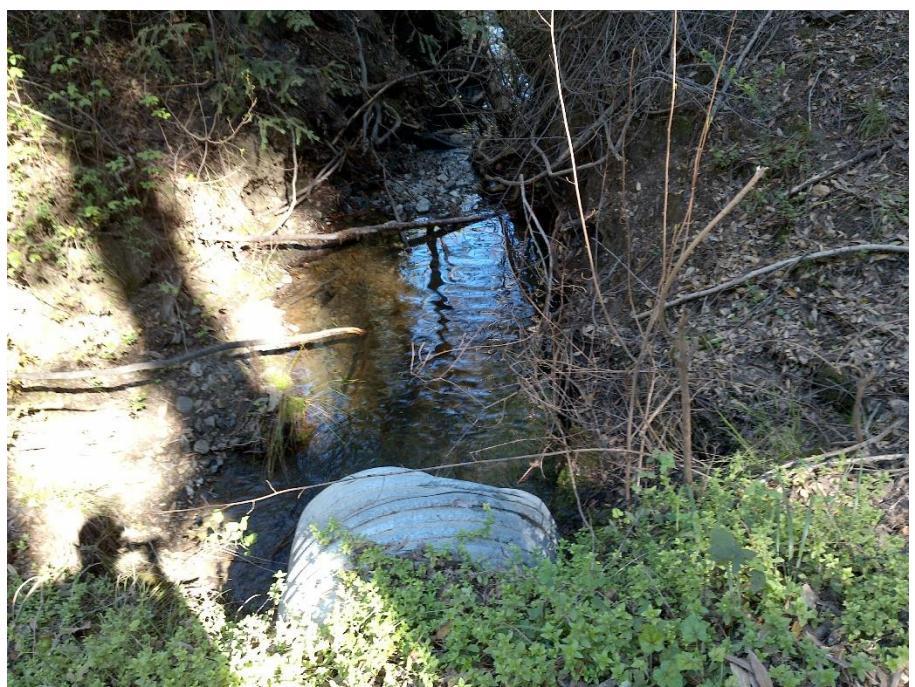
Photo 11— Looking northeast at the outlet for the culvert pictured in the previous image in the vicinity of WQ6. The culvert outlet is perched three feet above the channel bed and discharges into a scour pool.

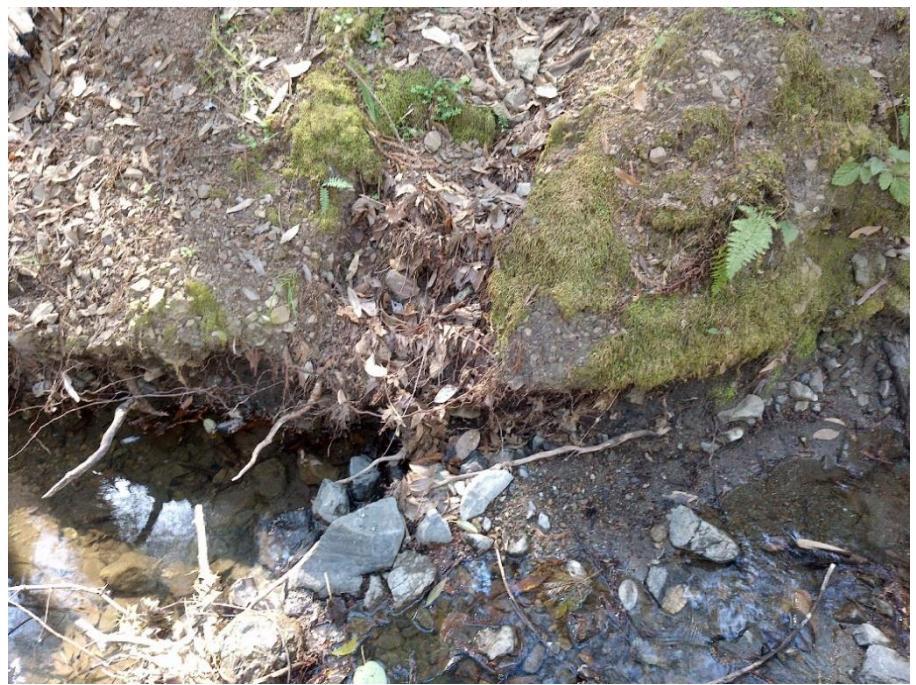
We returned to the receiving watercourse for the channel culverted at WQ6 and walked upstream to WQ7 where I observed a smaller Class III tributary entering the larger Class II watercourse (Photo 12 and Photo 13). We continued following the larger watercourse upstream to where it ran along the side of a road. At WQ8 I observed a drainage ditch connecting the road to the watercourse that flows downstream toward WQ7 (Photo 14). I walked up to the road immediately above WQ8 and observed that the entire section of road between WQ8 and WQ9 appears to be hydrologically connected to the adjacent watercourse (Photo 15).

Photo 12— Looking where a smaller tributary watercourse discharges into a larger stream at WQ7. The Class III tributary has a marginally defined bed and bank for a limited distance upstream, lacks flow, and is filled with leaflitter, whereas the larger Class II receiving watercourse has water flowing over cobble and gravel substrate.

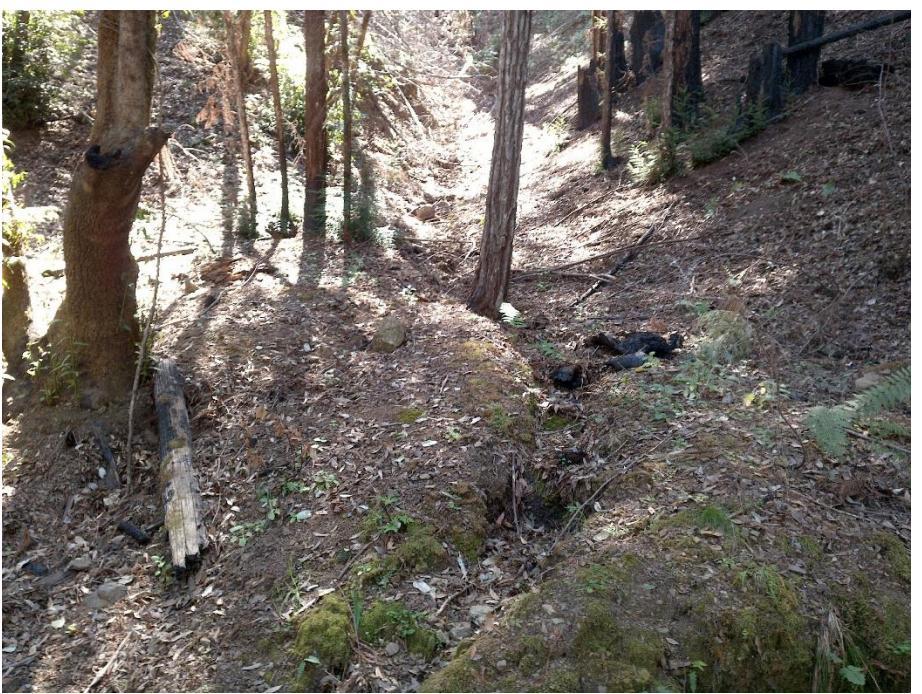
Photo 13— Looking south along a Class III tributary watercourse from WQ7.

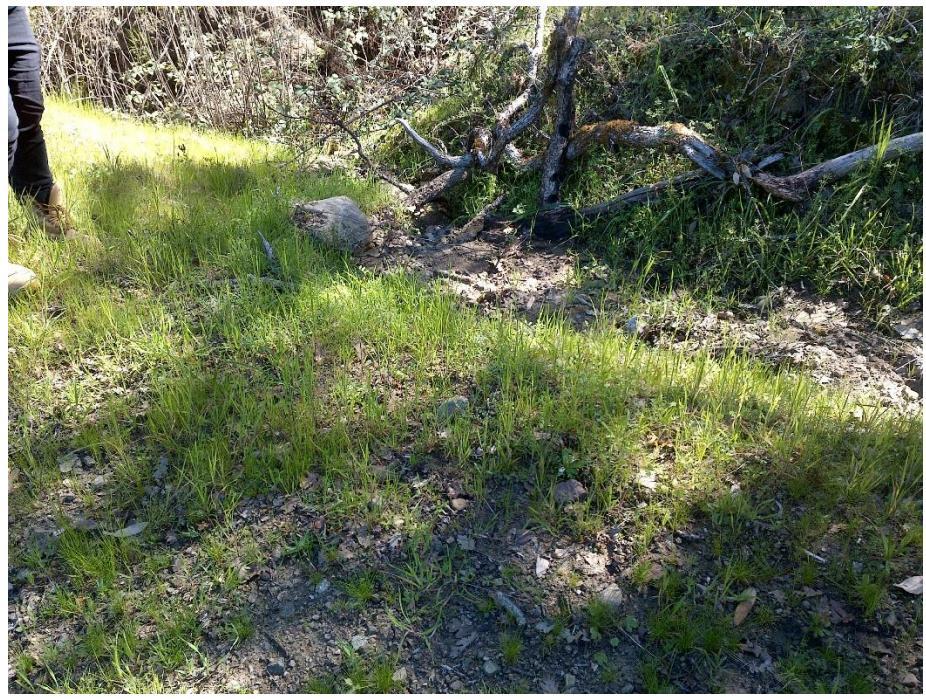
Photo 14— East side of the road at WQ8. A drainage ditch with lenses of fine sediment can be seen in the middle right of the image where stormwater from the road discharges into a watercourse out of sight in the top left of the image.

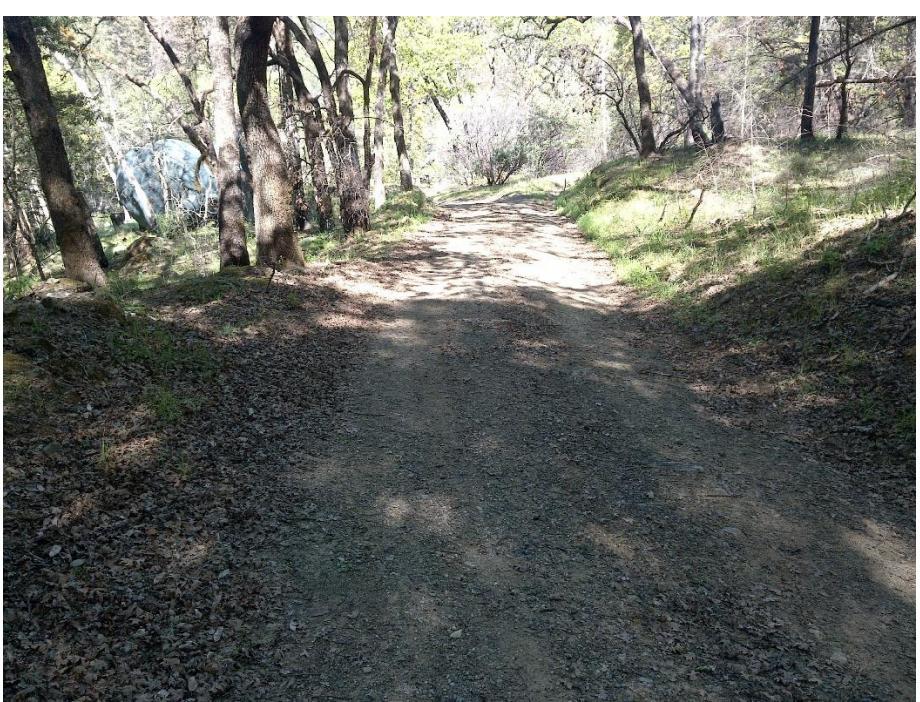
Photo 15— Looking north along road from WQ9. The road is shaped such that it will collect stormwater and discharge it to the watercourse at WQ8.

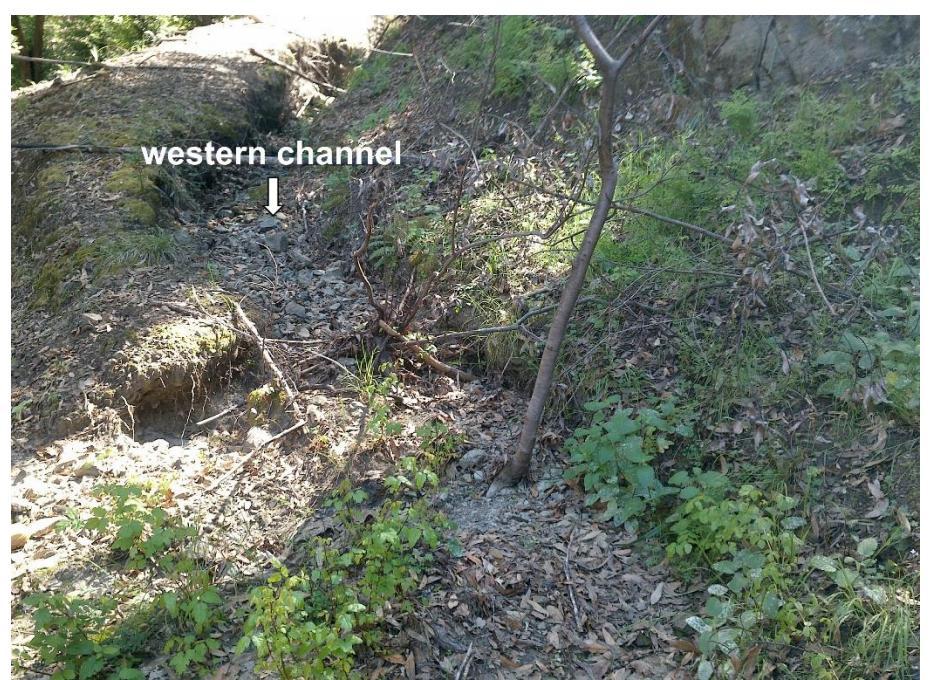
Photo 16— Looking south in the vicinity of WQ10. The watercourse (classification not determined) in the western channel is prevented from entering the road to the west by a concrete barrier behind the photographer which directs the flow to a culvert pictured in the next image.

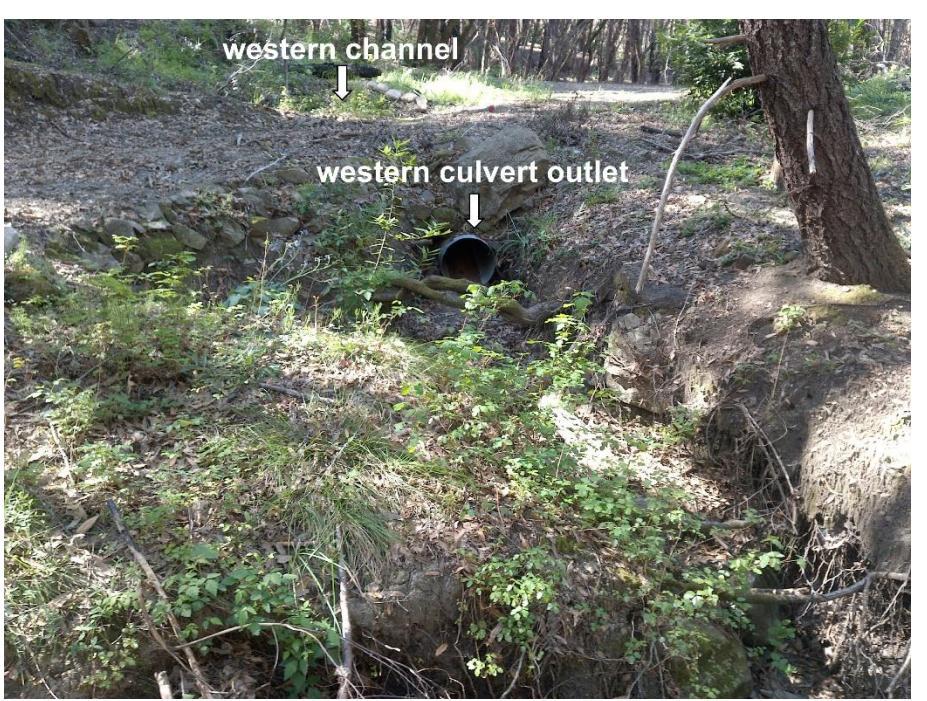
Photo 17— Looking west from the confluence of two watercourses (classifications not determined) in the vicinity of WQ10.

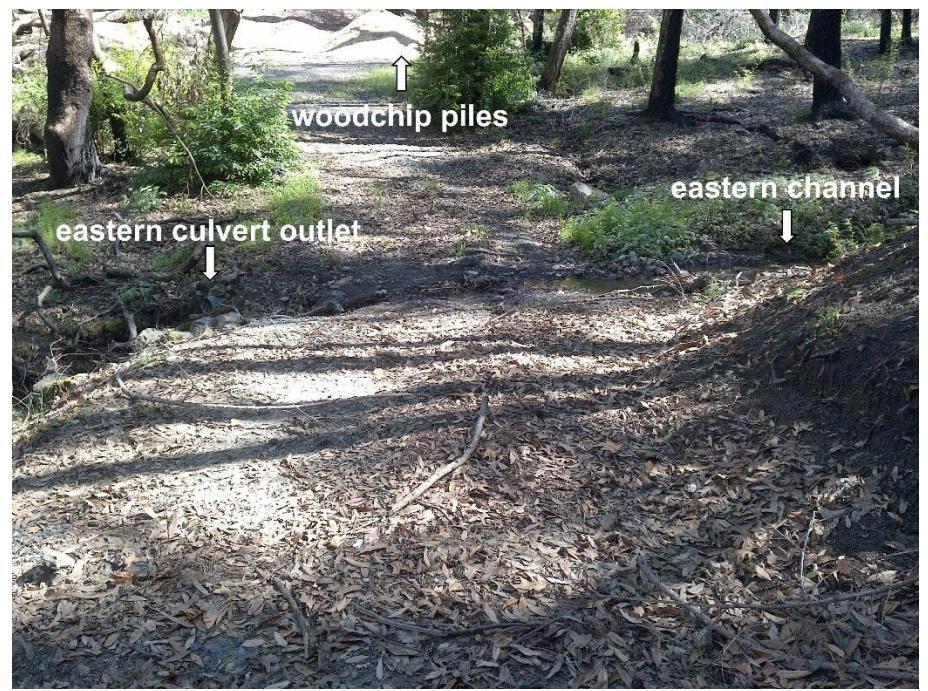
Photo 18— Looking east from WQ10. The watercourse (classification not determined) is flowing over the road and eroding the road fill. Several large piles of woodchips are visible in the distance at the top of the image.

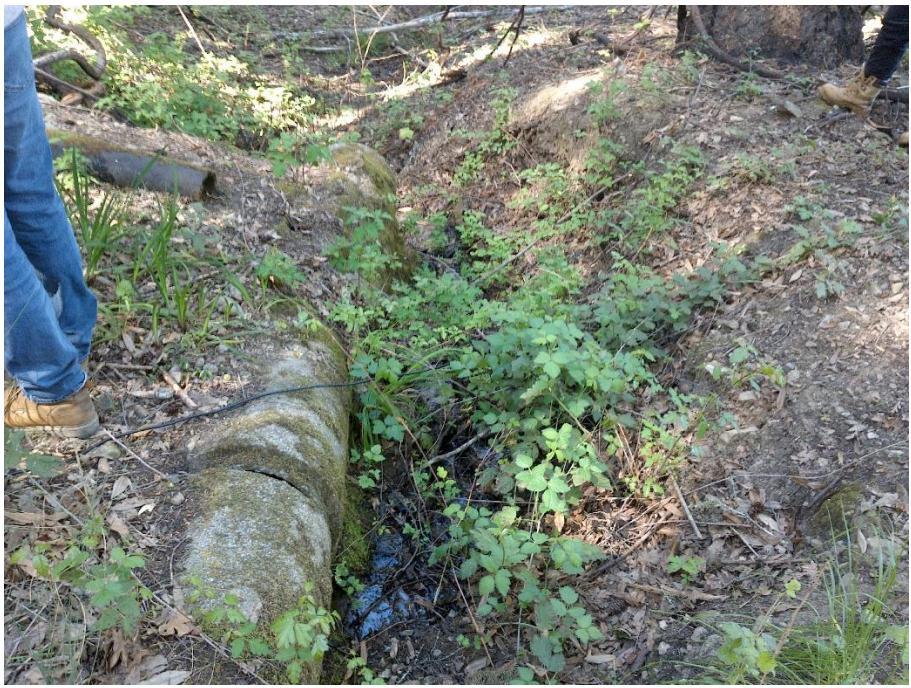
Photo 19— An 18-inch diameter concrete pipe in a Class II watercourse and other nearby refuse at WQ11.

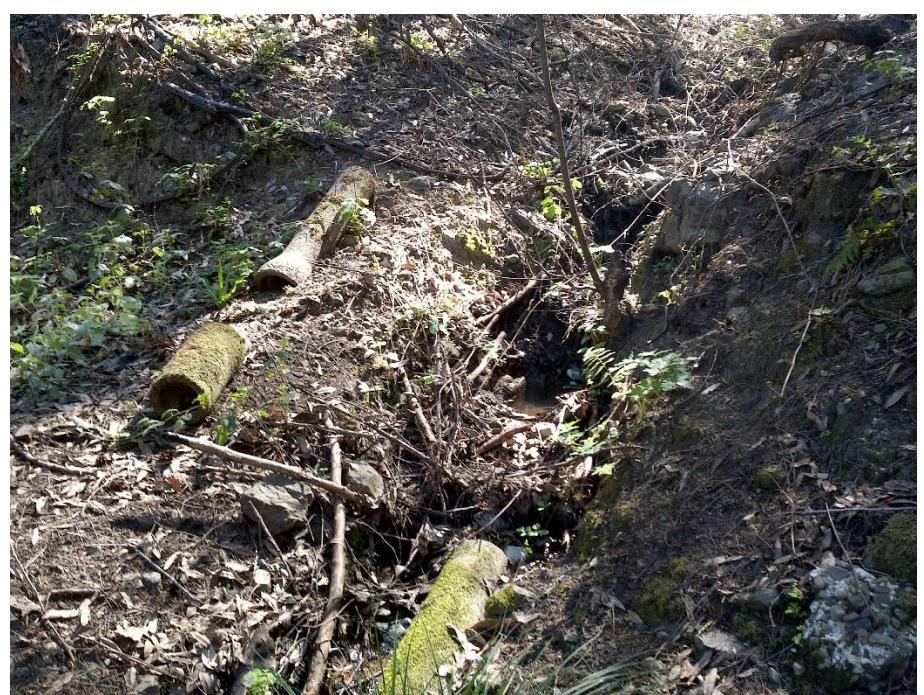
Photo 20— Segments of 6-inch diameter concrete pipe both next to and within a ClassII watercourse at WQ12.

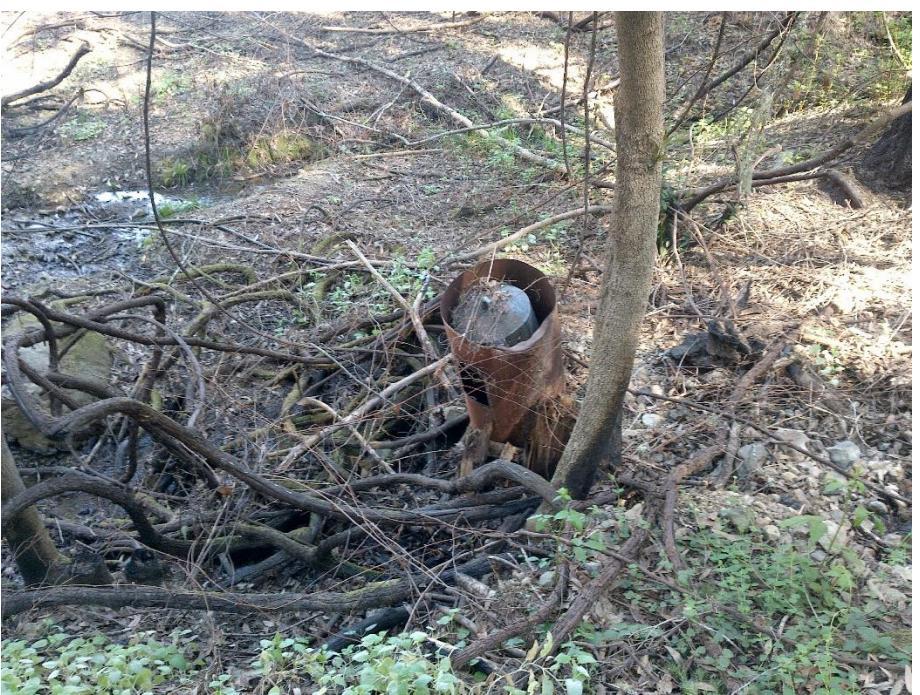
Photo 21— Metal waste within a Class II watercourse downstream from WQ12.
