Re: Proposed Cannabis Permit, UPC18-046, 6699 Palmer Creek Road, Healdsburg

Subject: Review of Initial Study/Mitigated Negative Declaration SCH No. 2021040407 Evergreen Acres, LLC (UPC18-00046)

Evergreen Acres LLC March 11, 2022 Inspection CIWQS Place ID. 847681

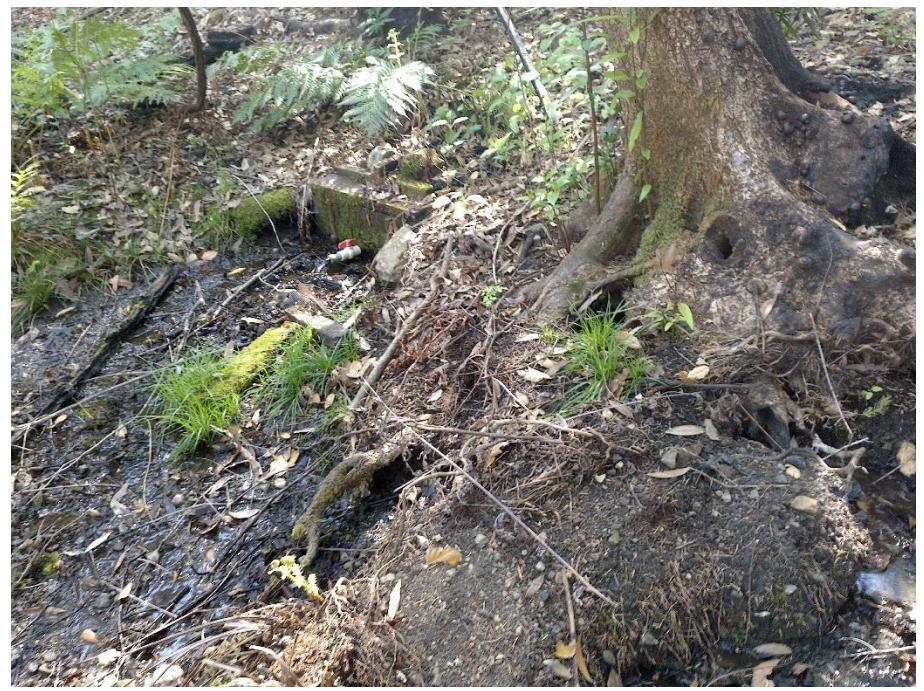
Photo 22— A developed spring at WQ13. Springwater is flowing through an open valve extending from a wooden box constructed into a hillside. Springwater is also emanating from the ground and from below a tree in the vicinity of the spring box.

The 2022 NCRWQCB inspection report also identified a perennial spring within the proximity of the western stream system (NCRWQCB inspection point WQ13). We observed this spring location during our site inspection. We understand that the presence of a perennial spring, by default, requires a 150-foot setback. While the spring area is proximate to the stream system it does not change the stream classification from a Class II. Therefore the 150-foot setback requirement is only related to the spring and not related to the entire stream system.

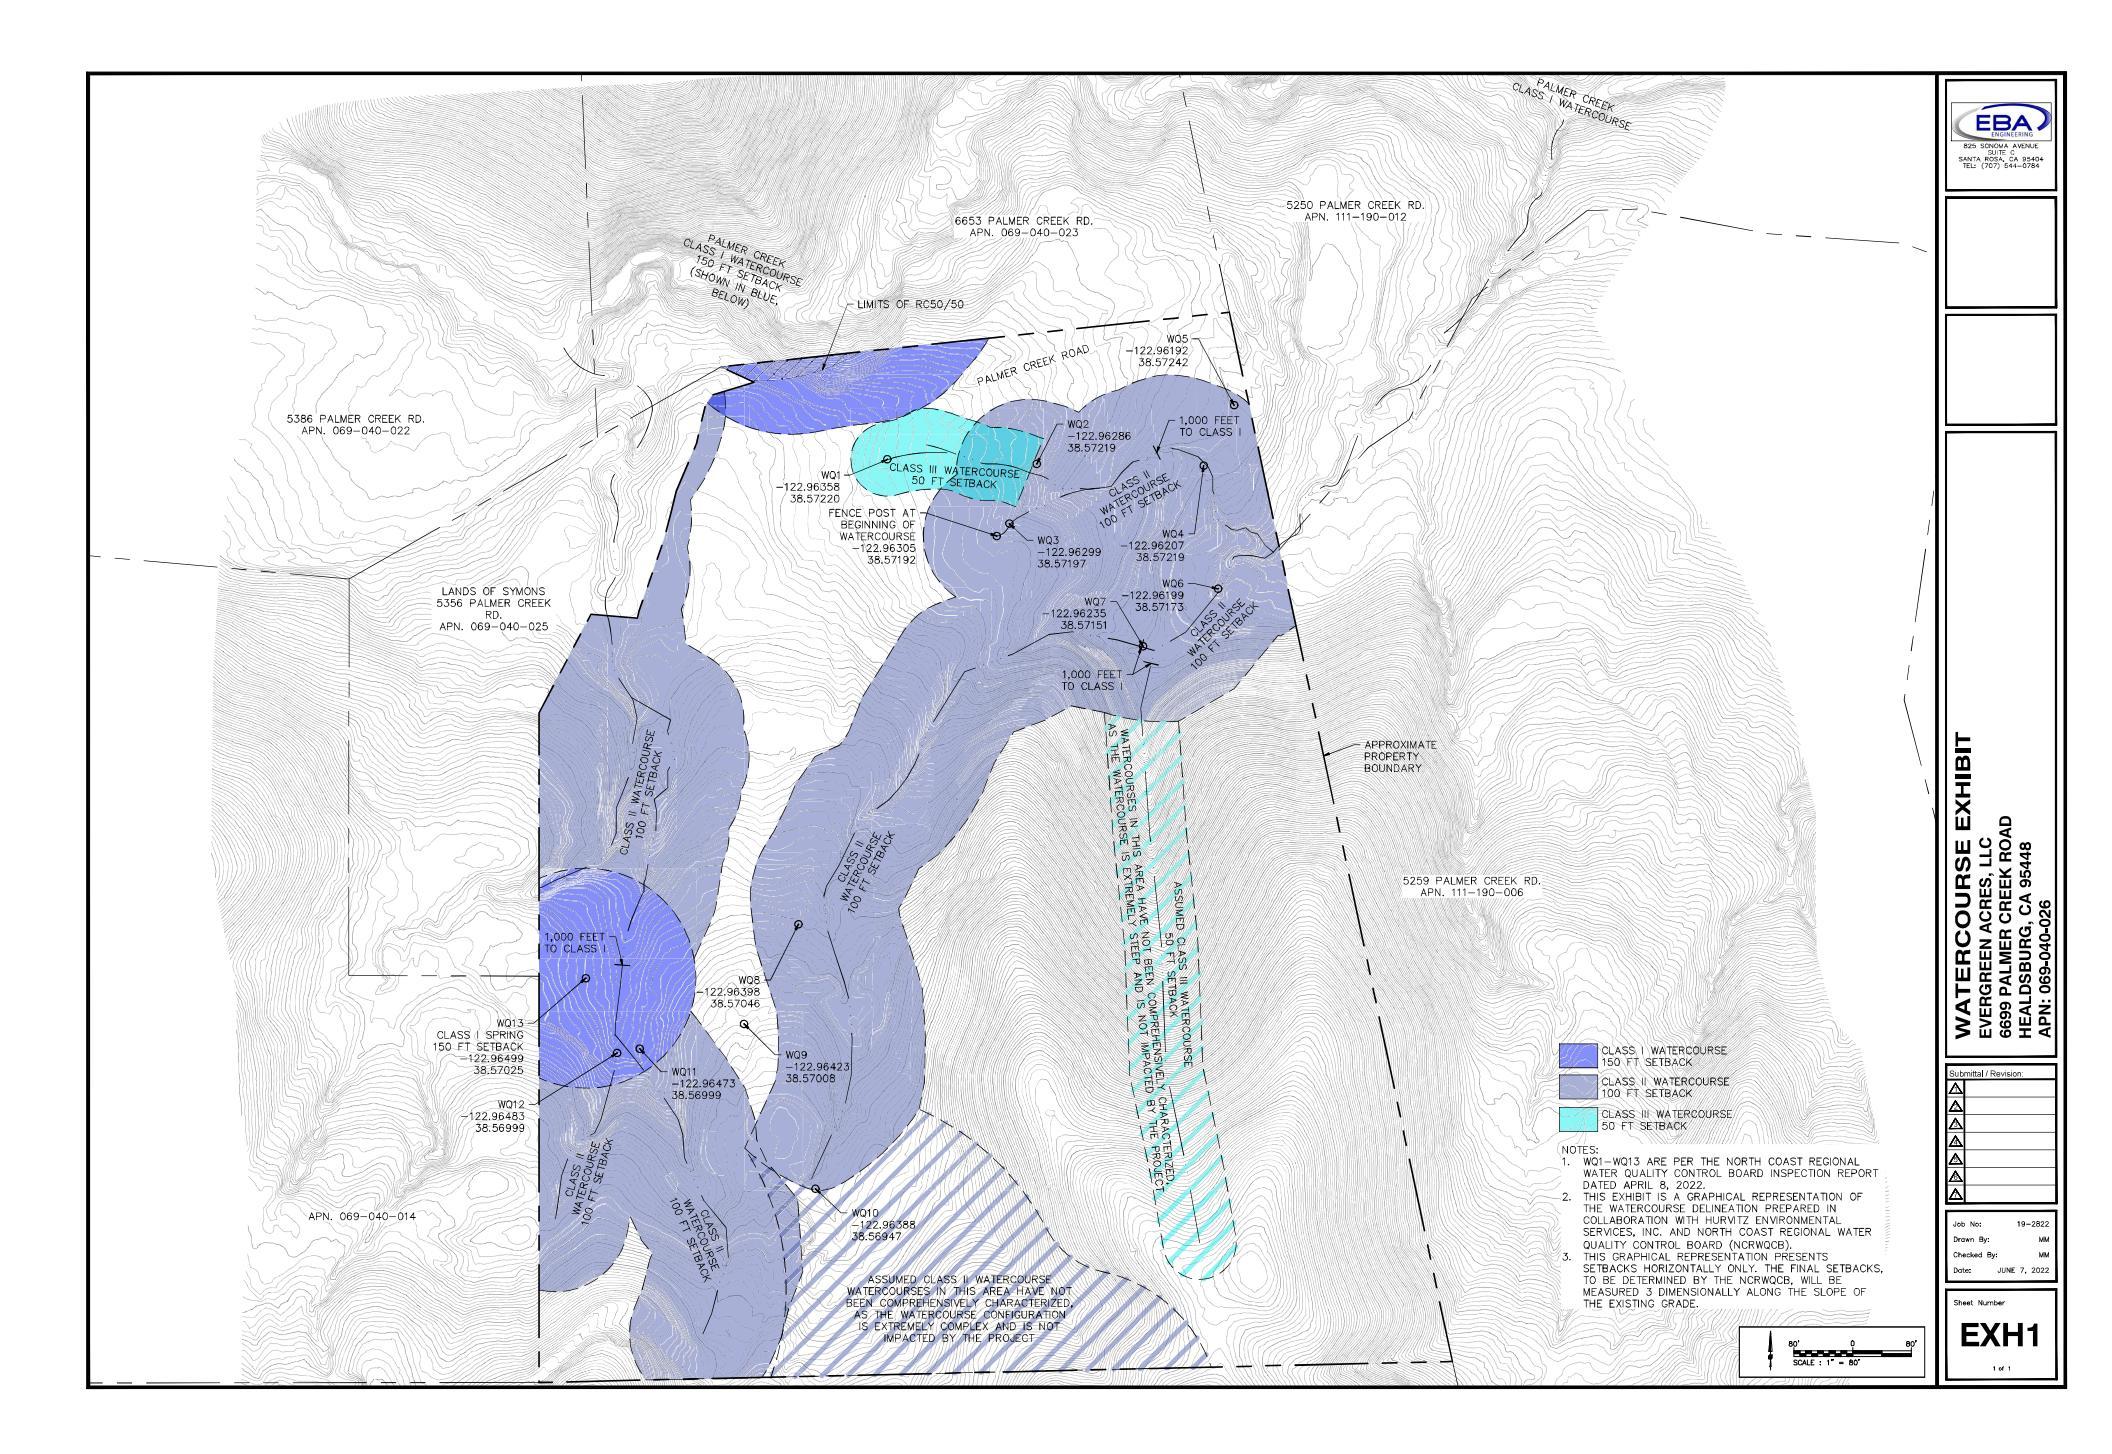
Appendix A EBA Engineering Watercourse and Project Setback Exhibit

A short easterly flowing Class III drainage was also identified near the northern portion of the site as shown on the Watercourse Classification Exhibit, Appendix B. This drainage is very subtle and appears to originate from the site access road east of the barn before traveling through a grassy meadow and merging with the Class II Stream near the northeast corner of the site. Only minor channelization was observed and no defined bank was present along most of this drainage. As the drainage flows easterly across the site, it transitions to steeper terrain shortly before merging with the Class II stream. The short portion of this drainage, located in steeper terrain, has significant incising and a defined bank. It is at this point that the drainage transitions from a Class III stream to a Class II Stream. The area where the Class II and Class II stream merge is clearly defined with the appropriate setbacks from these features designated on the attached Watercourse and Project Setback Exhibit, **Appendix A**.
