**LONG-TERM MONITORING AND MANAGEMENT PLAN
ALTON LANE CONSERVATION BANK
SONOMA COUNTY, CA**

January 30, 2020

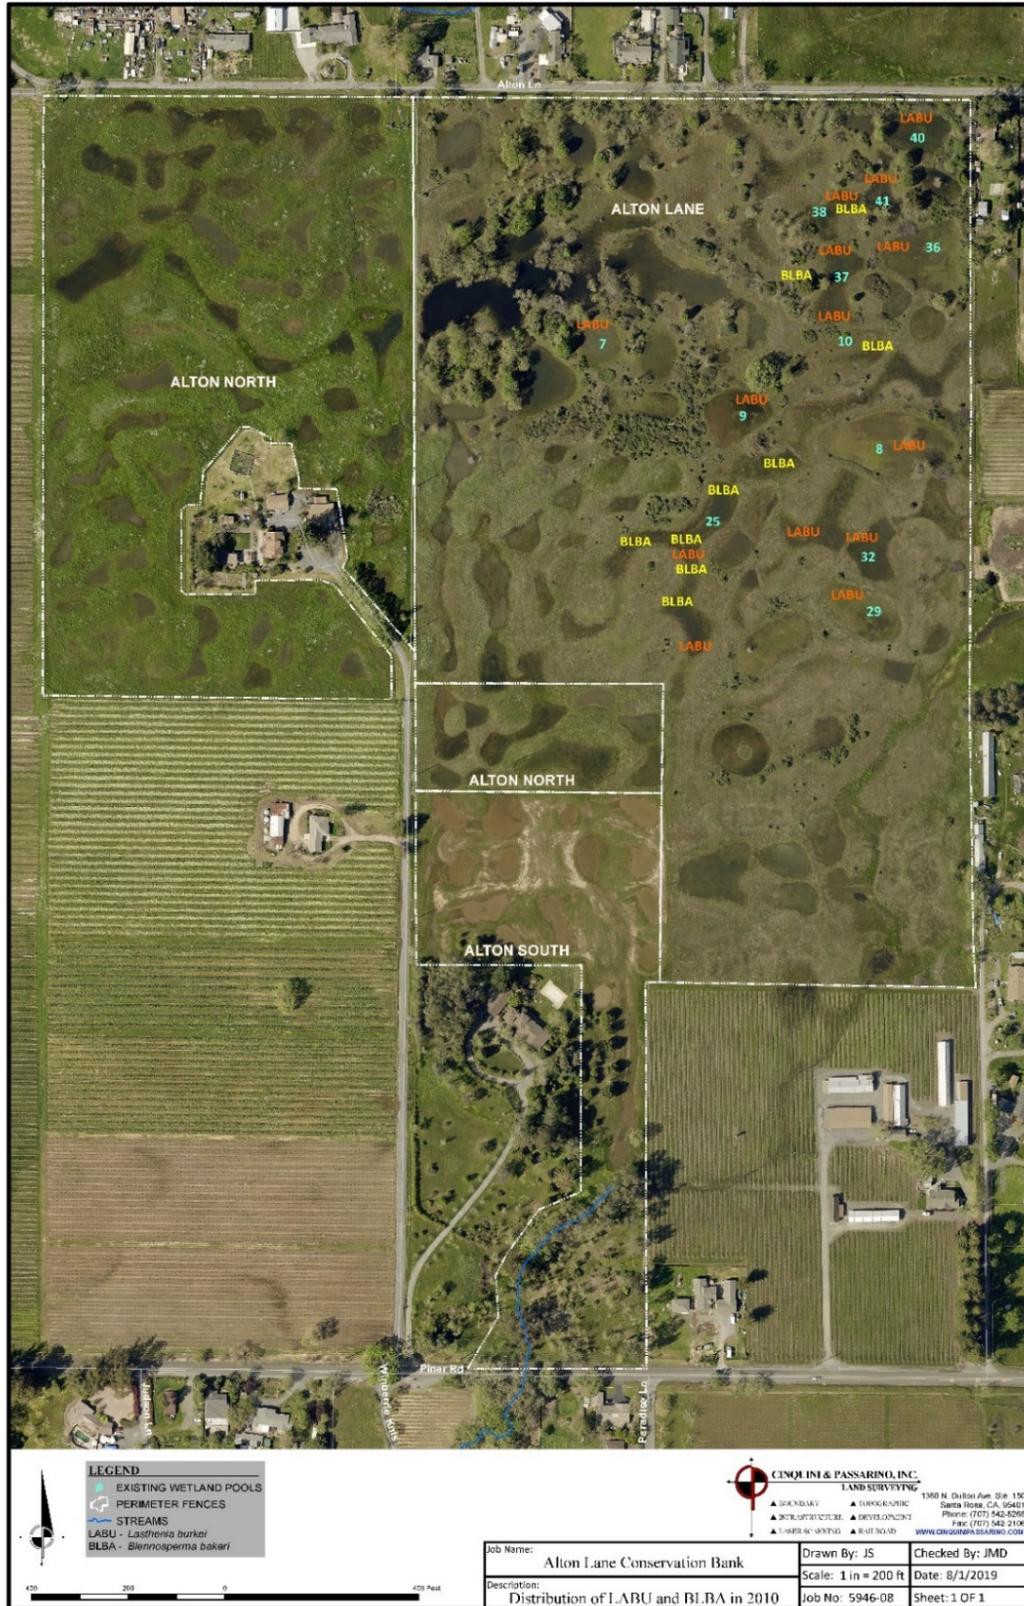
Figure 4. Vernal pools supporting populations of Burke’s goldfield and Sonoma sunshine in 2010. Pool numbers from Cook and Stokes (2019).

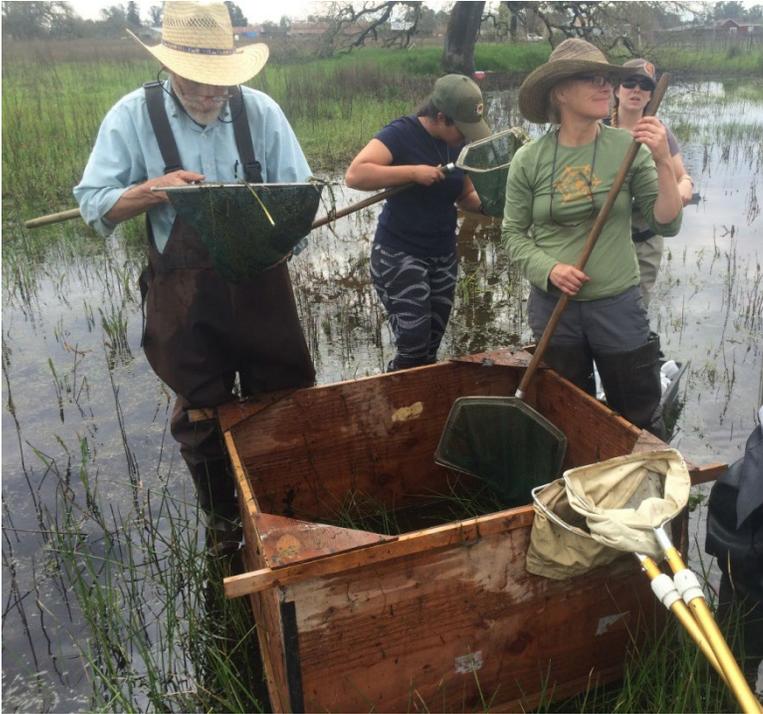
Figure 5: Box Plot enclosure sampling used to estimate the true population of CTS larvae in selected pools in spring 2015.

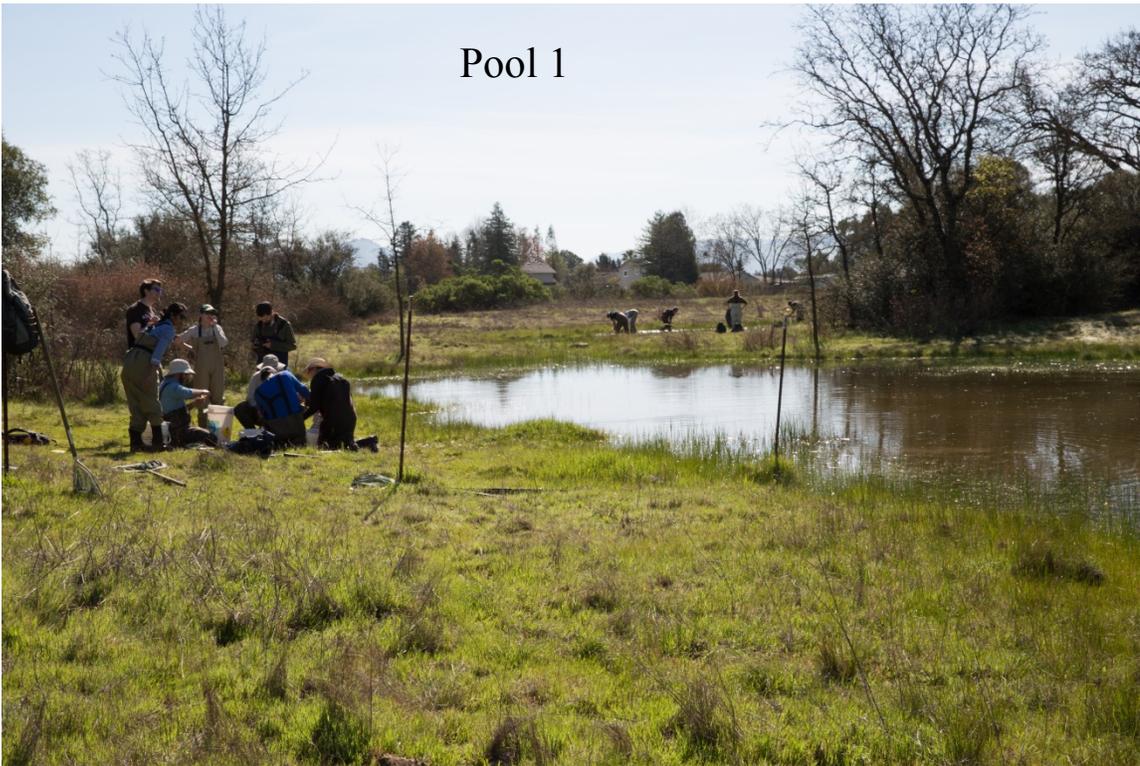
Figure 6: ALT constructed Pools 1 and 2. These pools were constructed by impounding a shallow swale. They are the largest and deepest pools and most productive for CTS at ALT.

The success of ALT is largely attributable to Pools 1 and 2 that are very productive CTS breeding pools. Pool 1 is the only pool that was active annually for 18 years without interruption, despite conditions of extreme drought. During the 2015 drought, Pool 2 produced four times the number of CTS larvae as high-value breeding pools at other studied preserves. Given their high value for CTS reproduction, the physical characteristics of ALT Pools 1 and 2 should be used as models when designing breeding pools for CTS conservation and recovery on the Santa Rosa Plain.

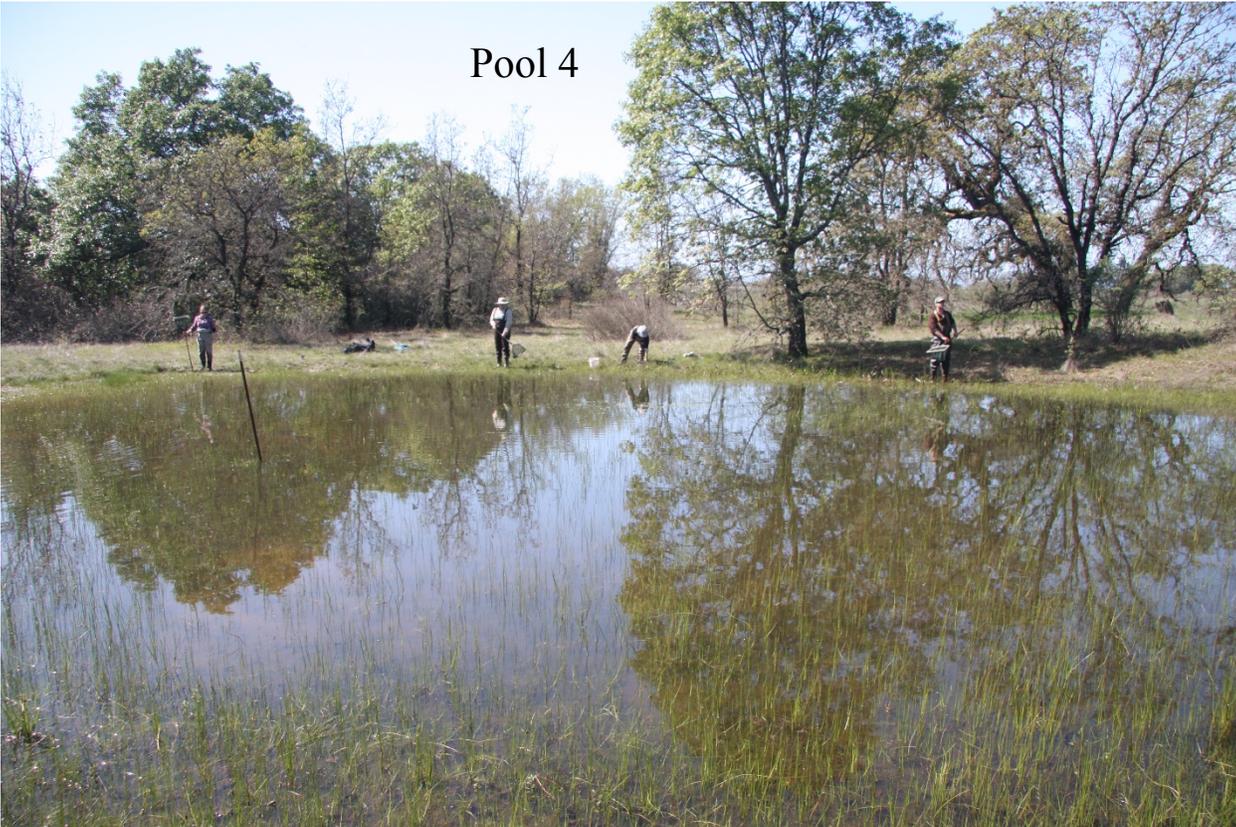
Figure 7: CTS breeding Pool 4 at ALT. This pool was constructed in uplands in 1989 and was colonized in 2006.
