Estero Americano Coastal Preserve Mitigation Project

Habitat Mitigation and Monitoring Plan

Sonoma County, California

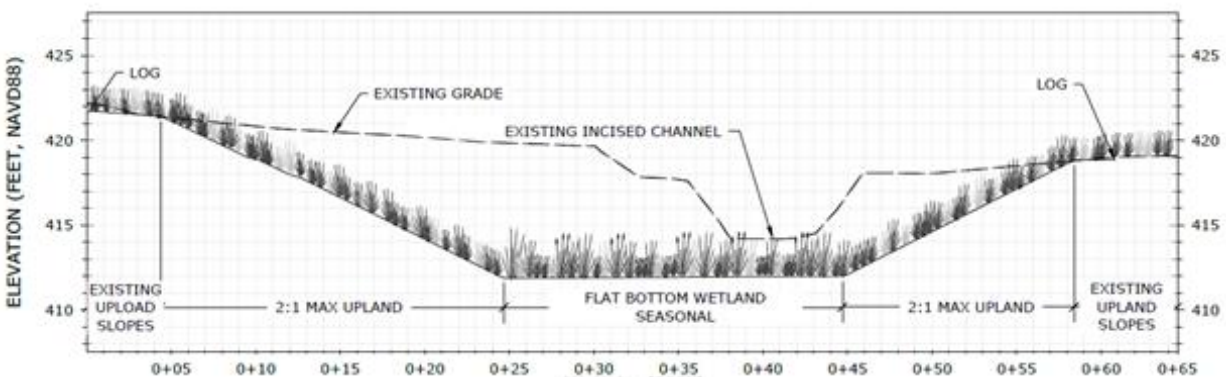
Figure A. Typical North Tributary Wetland Section

Work in the North Tributary will focus on removing erosional features that have caused a series of headcuts and deep, narrow gullies that appear to have lowered the water table, resulting in degradation of habitat and downstream sedimentation. The area will be graded to create a naturalistic swale that will allow overland and shallow subsurface flow to slowly move through the area, intercepting groundwater for an improved hydrograph. The slope of the restored swale feature will vary, and in steeper locations willow trenches and live willow stakes will be installed to attenuate flow, minimize erosion, and create diversity of habitat. Topsoil will be harvested and stockpiled for later re-use within this restored area. Native grasses and juncus bunches will be salvaged for replanting along the restored swale. Other areas will be planted with plugs of native seasonal wetland plants to restore a continuous wetland community. All areas will be seeded with a native wetland seed mix.

Error! Reference source not found.A below shows a typical wetland section for the restored area in the North Tributary.

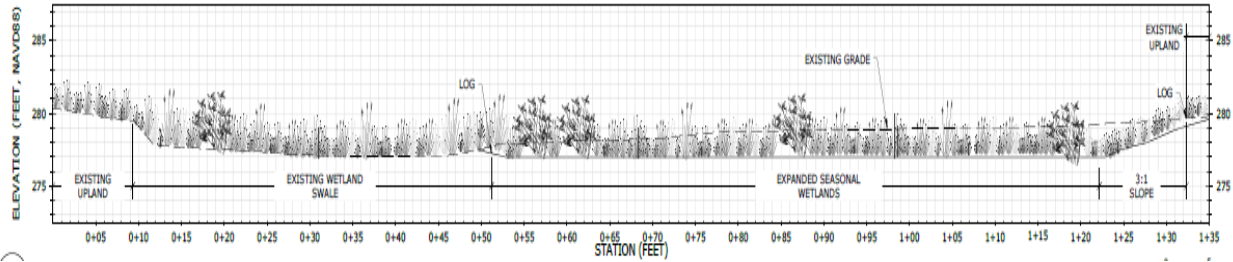
Figure B. Typical Middle Tributary Wetland Grading Section

The Middle Tributary will receive a range of implementation actions. The upslope end of the drainage is crossed by the apparent fault line that intercepts seeps and springs. Just upslope of the restoration areas, a spring has been developed/contained with a concrete box that holds perennial water. The spring box will be retained as is, with the tank and pump removed. The area immediately downstream has perennial flow through a broad diffuse wetland/stream area that has been degraded by cattle hoof shear and grazing. The wetland area immediately below the spring box that is dominated by *Juncus* will be preserved. Two shallow sloped seasonal wetland areas will be created adjacent to this area, with hydrology supplied by grading that will intercept shallow groundwater near the surface. Topsoil will be harvested and stockpiled for later re-use within this restored area. Native *Juncus* bunches will be salvaged for replanting within the created wetlands. **Error! Reference source not found.**B shows a typical section of the wetland restoration in the Middle Tributary.

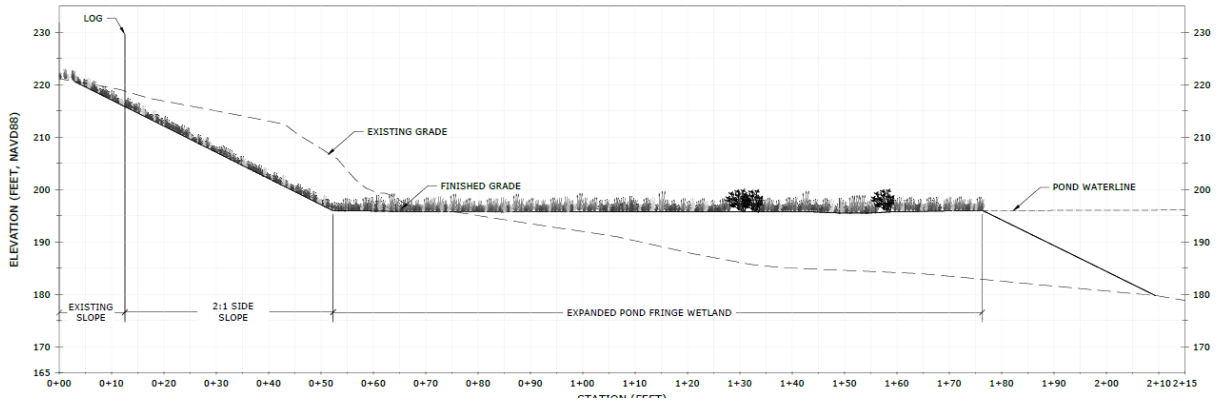
Figure C. Typical Pond Area Wetland Section

The pond edge will be expanded to create a wide wetland fringe. Grading of the deep marine deposits will create a wide bench and excess spoils will be used to convert a portion of the open water habitat to expand the emergent wetland area to provide cover for California red-legged frog and enhance the breeding habitat. Micro depressions will be graded to provide habitat diversity. All wetland areas will be planted with native freshwater marsh plugs and will also be seeded with herbaceous freshwater marsh species. The hydrology in this area is derived from seeps and shallow groundwater and is set by the outlet elevation of the pond allowing for a continuous source of wetland hydrology in all but extreme drought conditions. A shallow depression is located immediately upslope from the pond. This area will be deepened and planted with a wetland palette to provide enhanced habitat for California red-legged frog.

Just upslope of the created wetlands, a fringe of willow riparian habitat will be installed using live willow stakes. The willow plantings will continue around the west side of the pond at variable planting densities to account for several bedrock outcrops, with the goal of creating a continuous band of willow riparian habitat around the upslope areas of the pond. Due to dam stability concerns, the embankment will be allowed to remain in its current state. Figure C below for a typical grading section in the Pond Area.

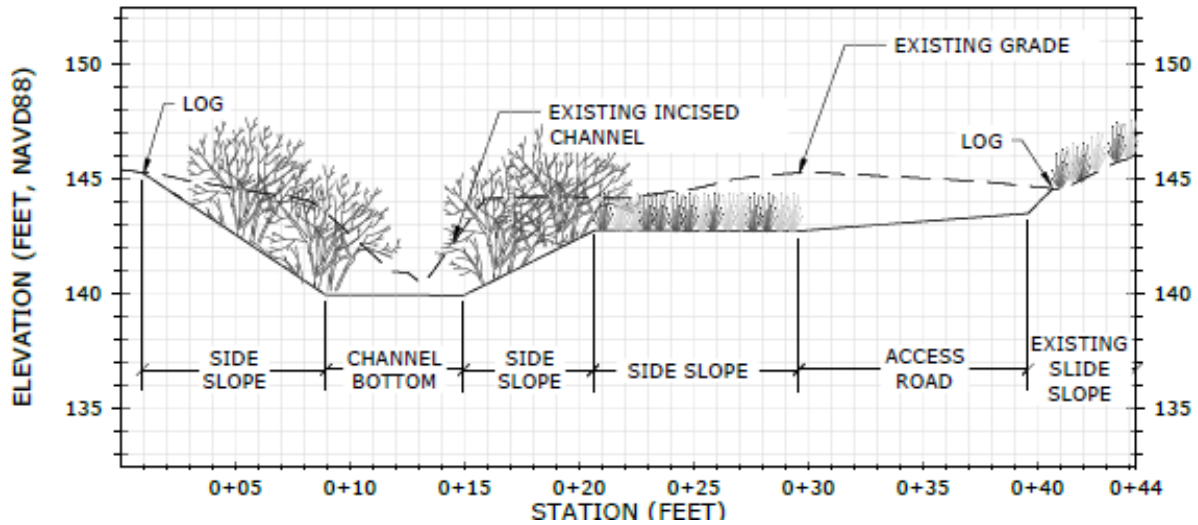
Figure D. Typical South Tributary Restoration

The South Tributary has experienced rapid erosion over the past 20 years, causing a deep gully to form that has resulted in high sediment delivery to Estero Americano and the loss of vehicular access to the Estero. Restoration actions will include regrading of side slopes and widening the bottom of the feature to minimize erosion and intercept shallow ground water and seeps. Side slopes will only be graded where necessary to create a flat-bottomed swale to support willow riparian plantings. Where possible, a wider bottom area will be created to allow for more willow riparian habitat development. Brush mattresses will be installed on the side slopes to further stabilize the slopes and provide scaffolding for willow riparian establishment. Brush mattresses will also be installed in the incised gully within the lower reach of the Southern Tributary to stabilize this channel and allow willow riparian to become established along this section of the channel. Additional riparian plantings are proposed within this lower section of the Southern Tributary.

Topsoil will be stockpiled for later re-use within the restored tributary. Willows and wetland vegetation will be salvaged where possible for replanting within the channel. The bottoms and all graded slopes will be seeded with wetland species and planted with live native willow stakes to create a continuous, dense riparian corridor. Figure D below shows a typical section of the South Tributary.
