ATTACHMENT 9B:
Mitigated Negative Declaration Technical Studies -
Historic Resource Evaluation

A HISTORIC RESOURCE EVALUATION OF THE PROPERTY LOCATED AT 334 PURVINE ROAD, PETALUMA (VICINITY), SONOMA COUNTY, CALIFORNIA

September 29, 2017

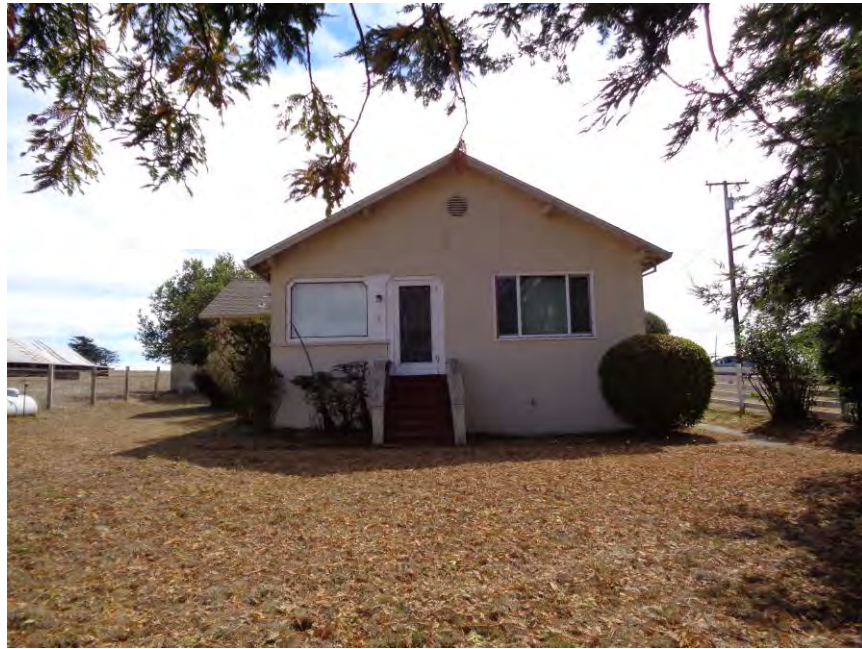
The ca. 1933 house is a single-story vernacular house with a raised foundation, front gable roof, and an L-plan design. The house is clad in stucco with a moderate pitched roof with exposed rafters (Figure 10). The roof is clad in asphalt shingles, and there are round metal roof vents along the roof line. The primary facade is an asymmetrical design and consists of concrete stairs, two windows, and a front entry door (Figure 11). The window near the northeast corner and the door are trimmed with wide wood detail that is angled along the top portion, and separated by wood that mimics a column. One of the windows is a fixed picture window, and the other window is a replacement vinyl window. The trim around the vinyl window appears to have been altered as it is different than the trim along the picture window. There is a wood front entry door with divided lights that appear to be original to the house. The east elevation consists of four vinyl replacement windows that are trimmed in wood, of which one is trimmed at an angle along the top portion, and the walls are clad in stucco (Figure 12). The west elevation consists of five vinyl replacement windows, of which two are paired windows, and there are single-hung windows. Each of the windows are trimmed in simple wood casings and the walls are clad in stucco (Figure 13). The south elevation consists of a lower extended gable roof, which may have been an addition, two paired vinyl windows, and one single-hung vinyl window (Figure 14). There are red stained concrete stairs with modern iron hand rails that lead to a rear entry door. The door appears to be a replacement door. There is also a metal porch awning that is in fair condition.

Figure 10. Photo showing the north elevation (primary façade), facing southeast.

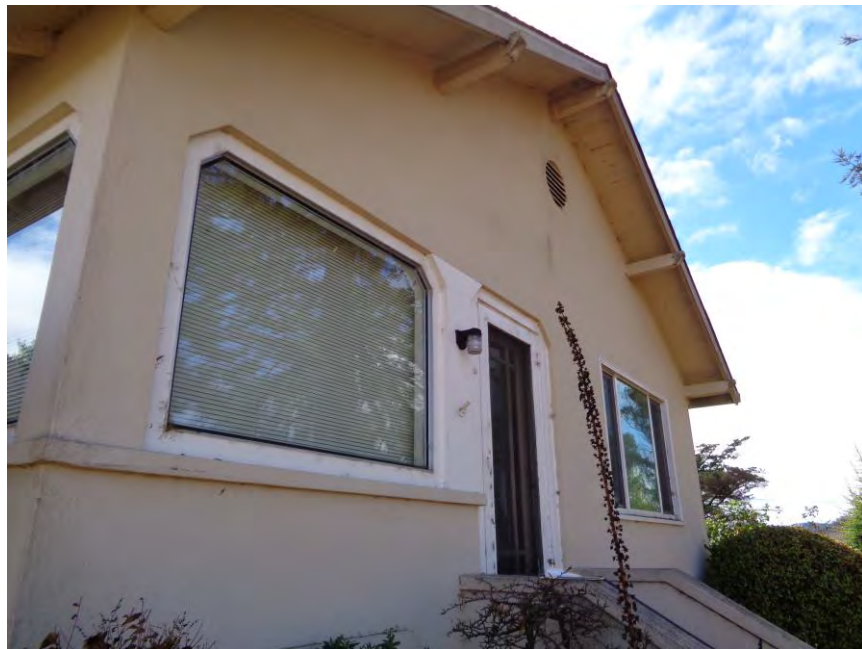
Figure 11. Photo showing the primary façade, facing south/southwest.

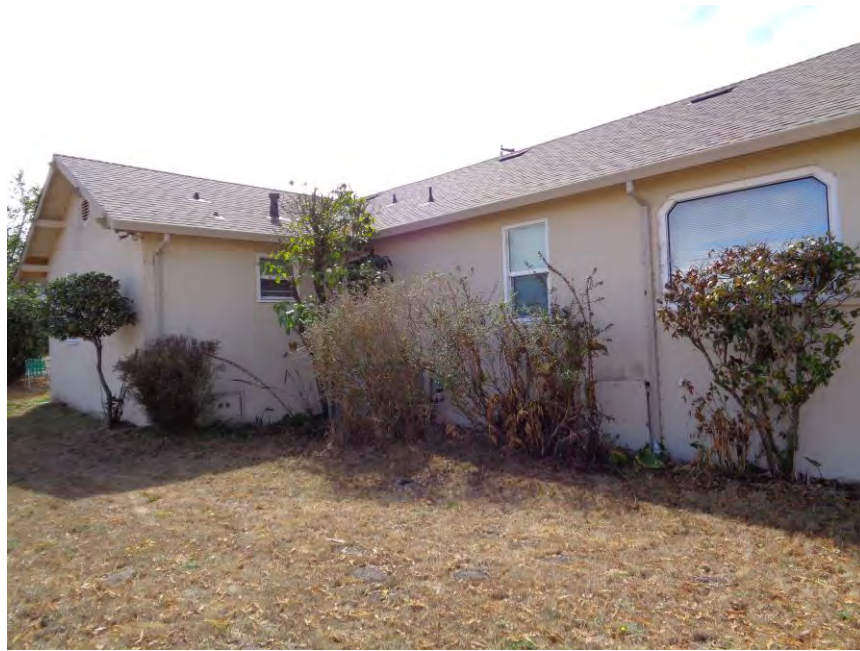
Figure 12. Photo showing the east elevation, facing south.

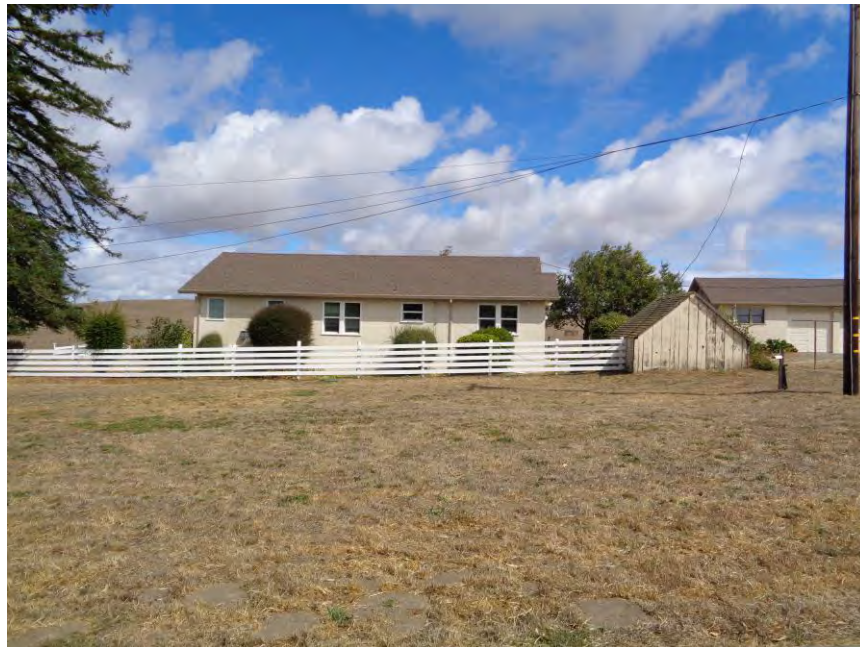
Figure 13. Photo showing the west elevation, facing northeast.

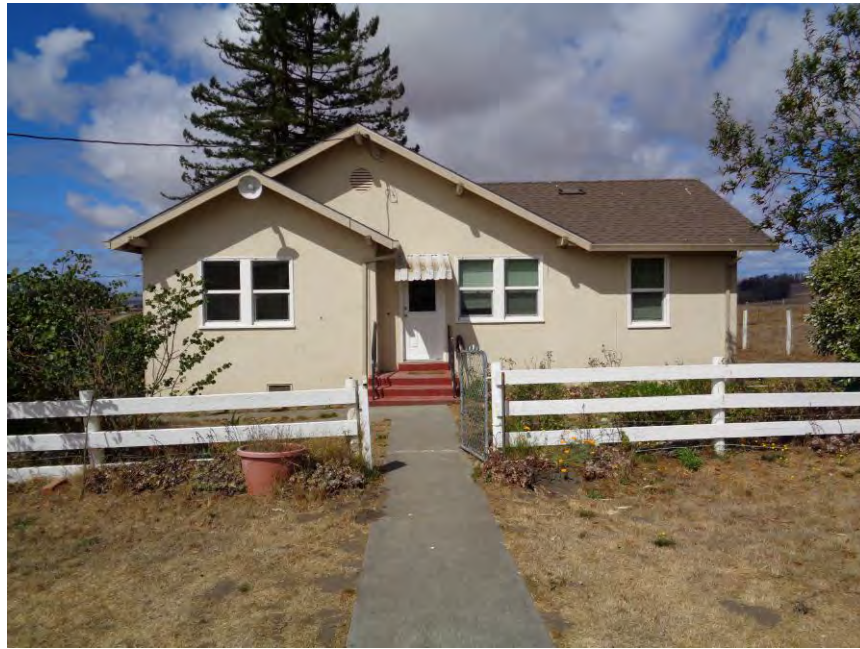
Figure 14. Photo showing the south elevation, facing northwest.

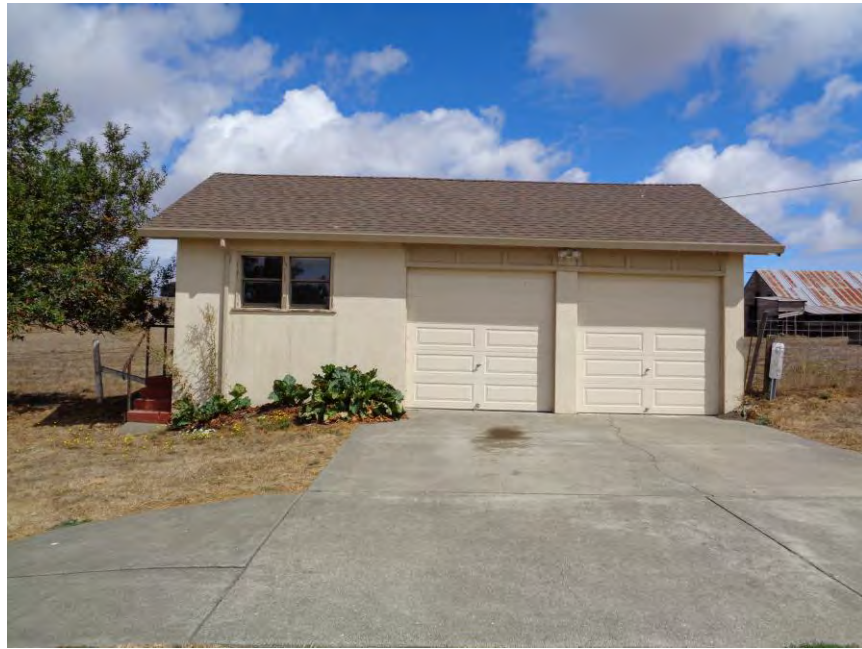
There is a side-gabled detached garage located approximately 28.0 feet south/southeast of the ca. 1933 house that appears to have, at one time, served as an office. The building consists of a moderate pitched roof that is clad in asphalt shingles and is clad in stucco. The west elevation consists of modern double garage doors that appear to have been added in more recent years (Figure 15). There is a paired vinyl window along the west elevation and double-hung vinyl window along the north elevation. The windows appear to be trimmed in the original wood casing. There are red stained concrete stairs along the north elevation that lead to a side entry door that appears to be original to the building (Figure 16). The south elevation is void of any windows and the east elevation consists of two, double hung vinyl windows with original wood trim.

Figure 15. Photo showing the southwest elevation, facing northeast.

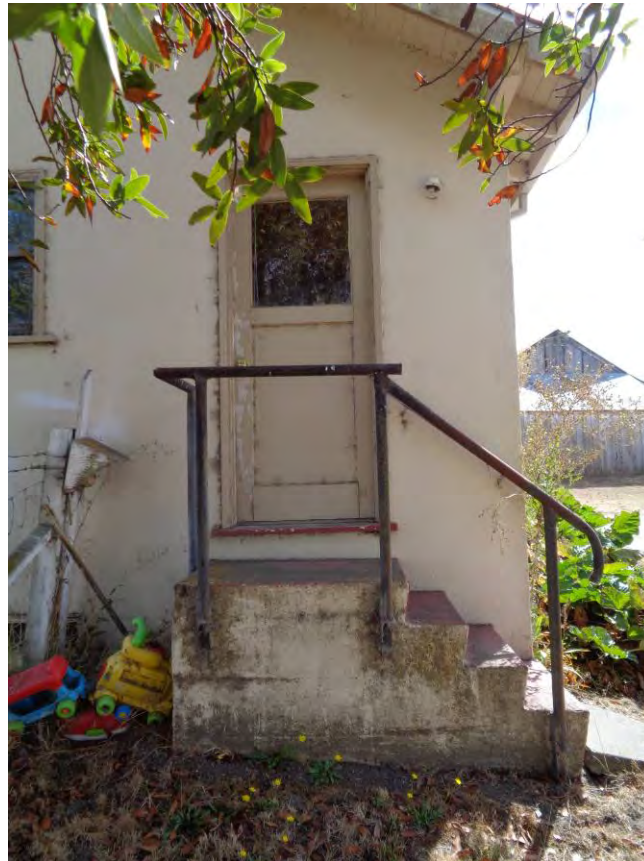
Figure 16. Photo showing the north elevation, facing southeast.

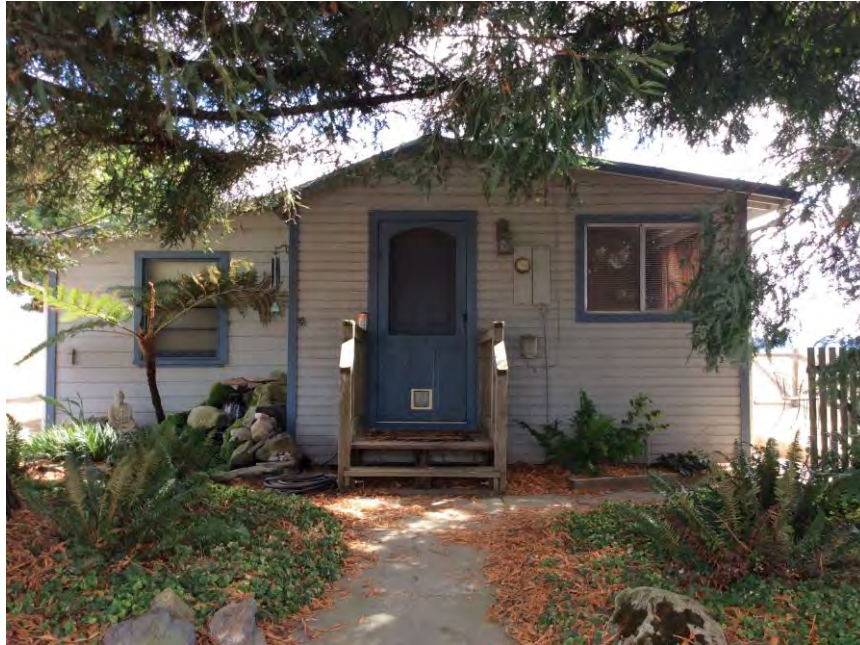
The ca. 1940 “mother-in-law” house consists of a low pitched front gabled roof and a set-back shed addition. The house is rectangular in plan and clad in tongue and groove horizontal wood (Figure 17). The north elevation (primary façade) consists of a front entry door and two windows, one aluminum slider window and one vinyl single hung window. The west elevation consists of three aluminum slider windows, and a side entry door that leads to a deck. The south elevation consists of a one slider aluminum window and a single-hung vinyl window. The east elevation consists of three slider vinyl windows.

Figure 17. Photo showing the north elevation, facing southeast.

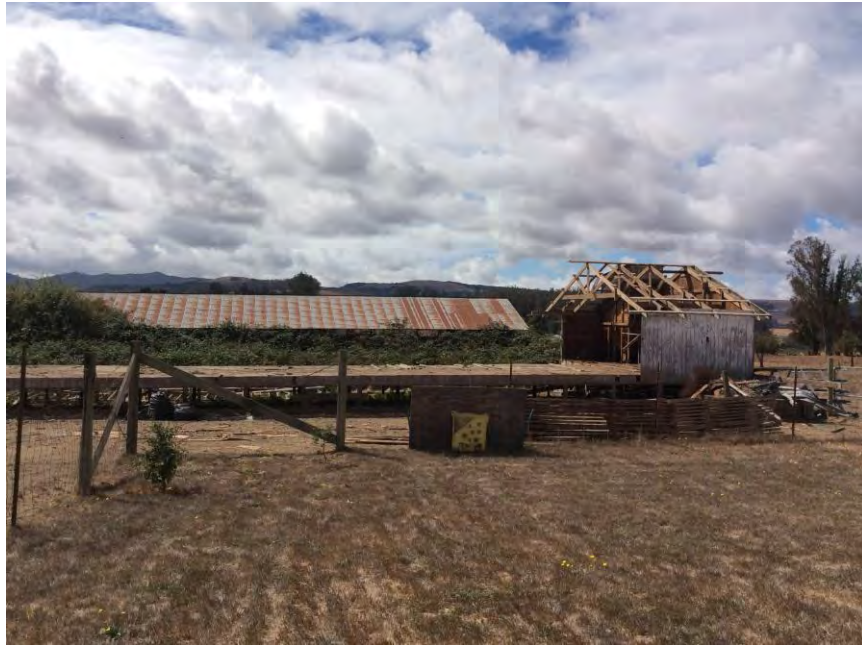
Chicken Barn 1 is a partially deconstructed building that was approved for demolition by the PRMD (September 2017) prior to the historic architectural field survey. As such, the details are limited to what is currently present. Chicken Barn 1 is a raised, rectangular plan, side gabled building that is representative of chicken barns buildings in Sonoma County during the early 1900s. Chicken Barn 1 is situated on a concrete perimeter foundation wall with square wood posts that support the floor of the barn (Figure 18). The floors are a narrow wood floors, and the walls, although on the ground, consist of chicken wire over wood framing.

Figure 18. Photo showing Chicken Barn 1, facing southwest.

- **CR-1** – Prior to demolition, EDS recommends that the Project proponent inventory the architectural elements to re-use on site or donate to the Sonoma County Historical Society or appropriate archival facility any associated artifacts or other architectural elements identified by EDS Principal Architectural Historian, that are feasible to archive or store. The associated artifact or architectural element shall be carefully removed and delivered to the archive facility in good condition to be used in future conservation work.

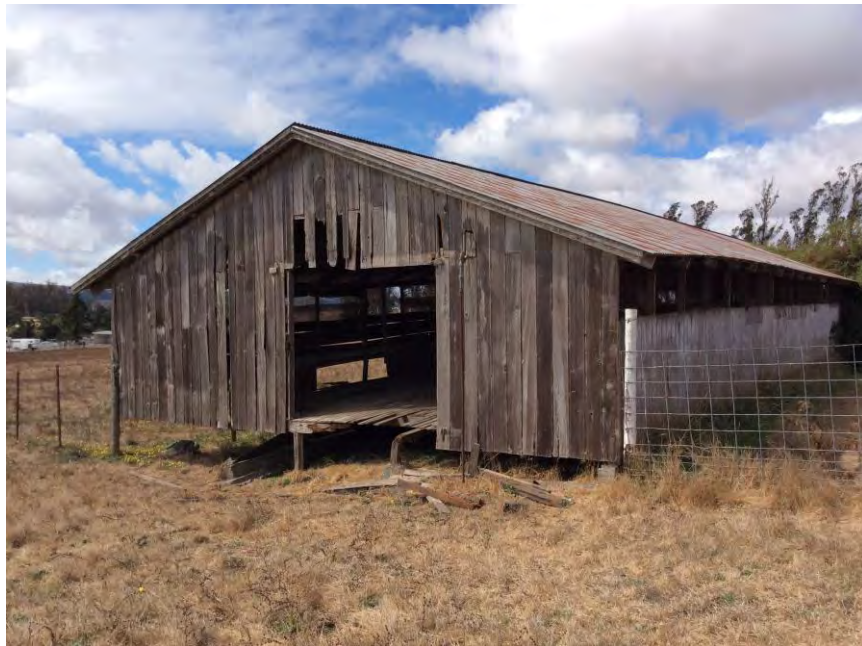
Chicken Barn 2 consists of a raised, rectangular plan, side gabled building that is representative of chicken barns buildings in Sonoma County during the early 1900s (Figure 19). Chicken Barn 2 is situated on a combination of post and pier and concrete perimeter foundation with narrow walls with square wood posts that support the floor of the barn. The roof is clad in corrugated metal and is constructed in a King Post framing system. The walls are call in vertical wood boards and are in fair to good condition. The floors are a narrow wood floors and the walls consists of a series of open windows and lower

Figure 19. Photo showing Chicken Barn 2, facing north.

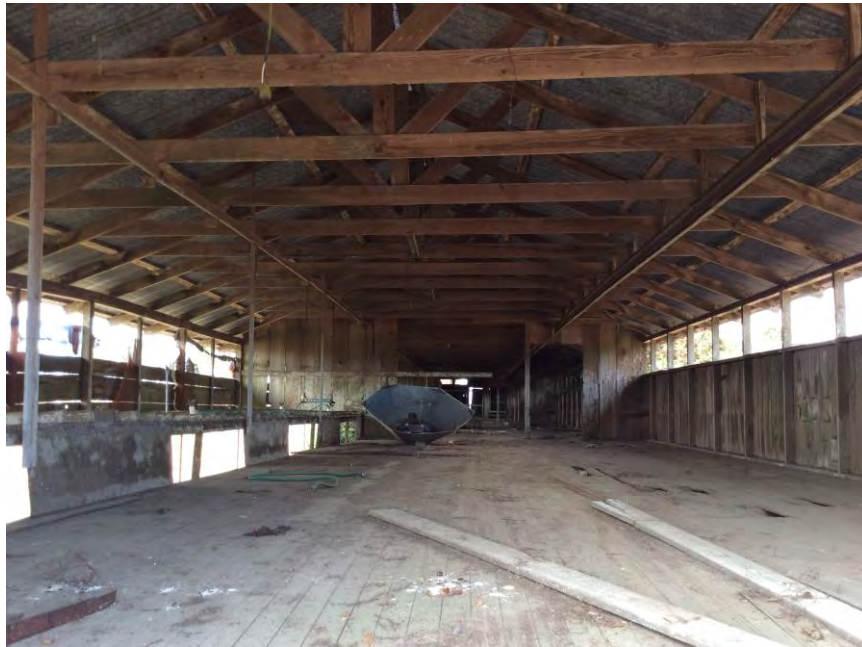
sections that are clad in wood. There is a metal feeder that is on the floor of the building and the building appears to be in fair condition (Figure 20).

Figure 20. Photo showing the interior of Chicken Barn 2.

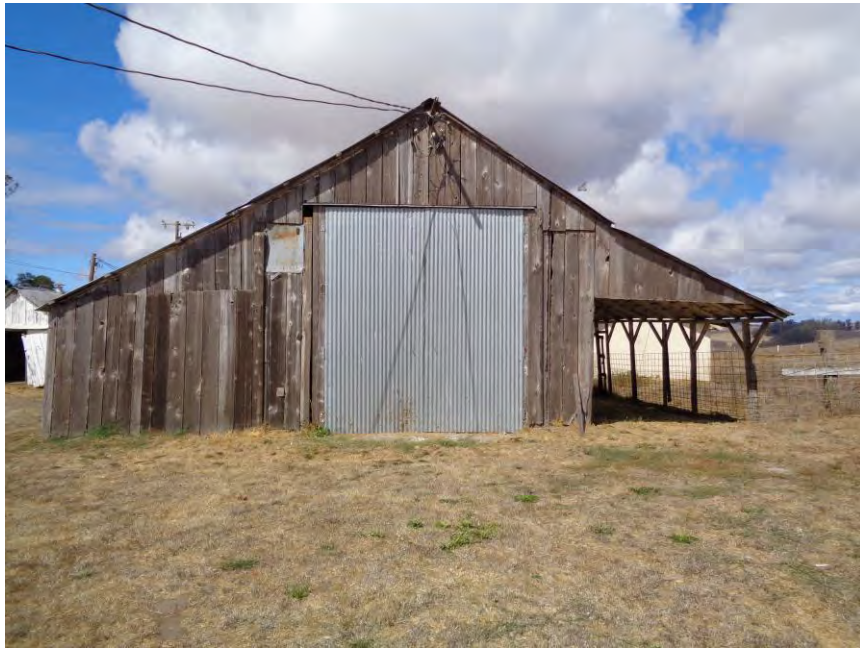
Barn 1 is a front gable plan with a centered section with metal doors that are flanked on each side by two bays (Figure 21). One of the bays is open and the other is enclosed. It is likely that both bay were originally open, but one bay was enclosed at a later date. The barn appears to have been used for grain and hay storage, as there are small hay loft casement and awning style doors along the upper portion of the east elevation that allowed for access to stored hay (Figure 22). There is hay hook along the south façade of the building. There is a shed addition along the rear (north elevation) of the building that may have been used for storage, but is open along the east elevation. A barn is situated on a concrete perimeter foundation, along the center portion of the board, but some sections rest directly on the soil. The interior of the barn was white-washed and there is evidence along the exterior that it was once painted red. The barn is in fair condition.

Figure 21. Photo showing Barn 1, south elevation, facing northwest.

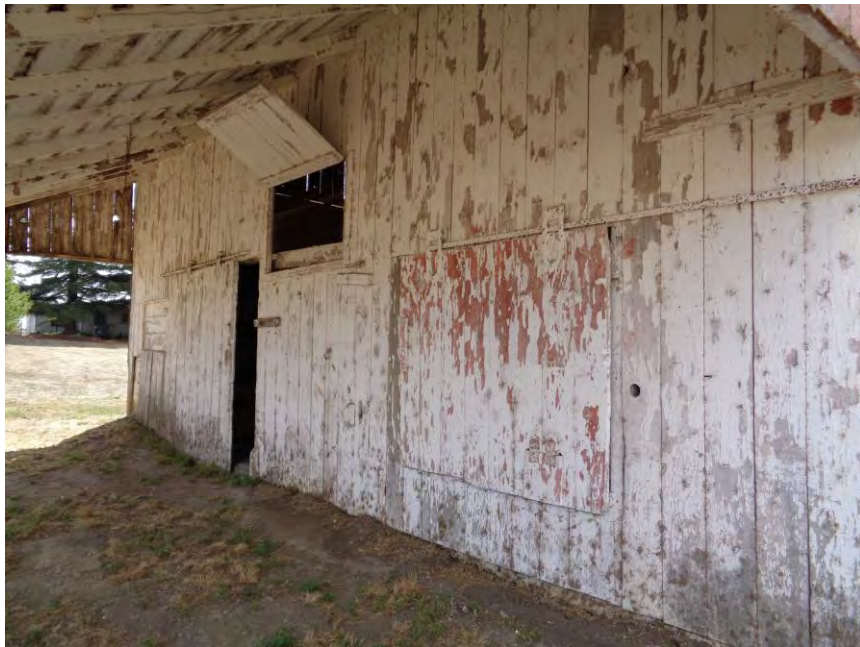
Figure 22. Photo showing the east elevation, facing south.

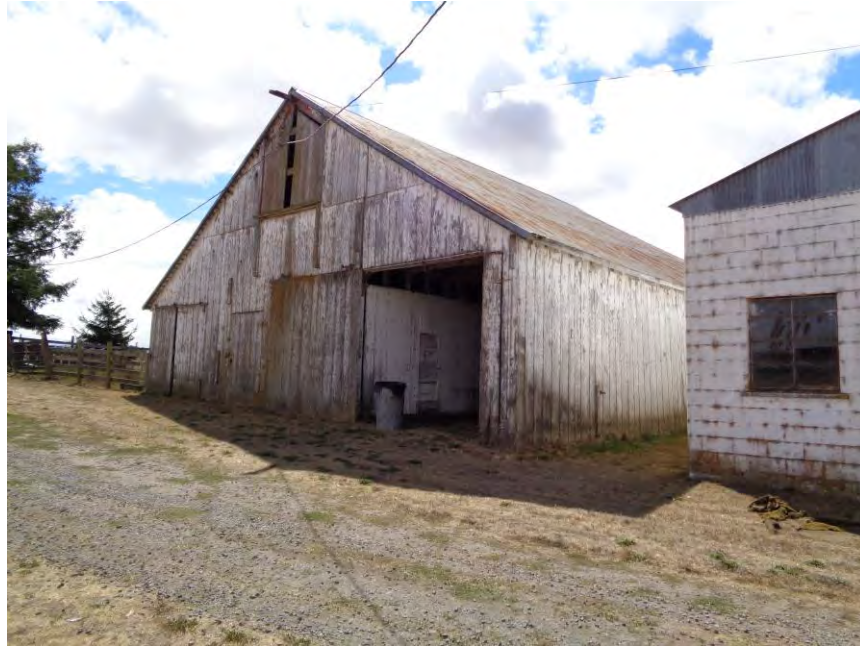
equipment such as tractors. The floor in the interior of the barn consists of both dirt floors and a portion consists of a raised wood floor, which was likely used to keep hay off the dirt floor. There is a section of the interior along the south side that consists of a small section that allows access to an exterior corral along the west and south elevation. The barn is in fair condition.

Figure 23. Photo showing Barn 2, east elevation, facing southwest.

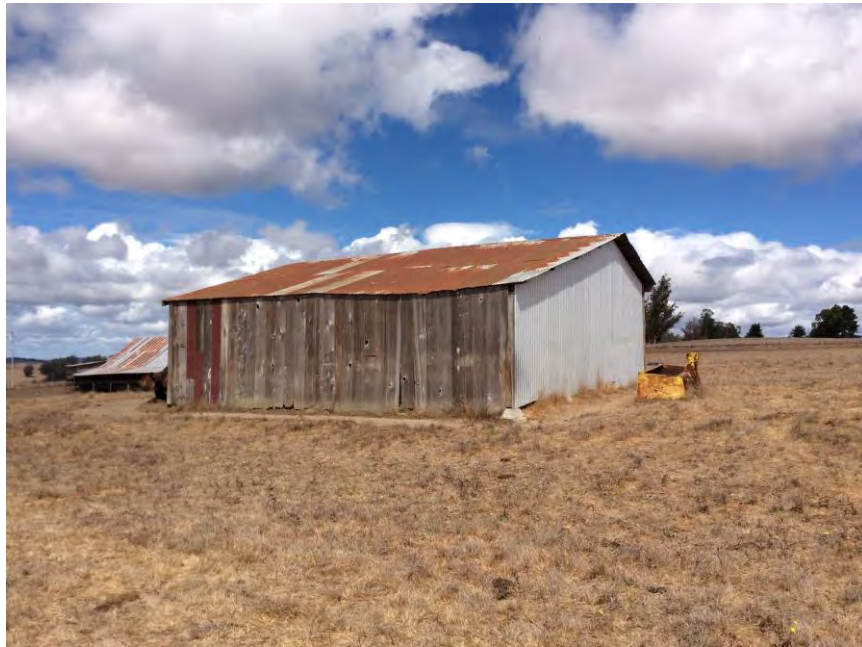
Barn 3 consists of a rectangular planned building with an irregular shaped front gable that consists of flush vertical wood boards and a roof that is clad in corrugated metal (Figure 24). Sections of the metal and wood appear to be original; however, other sections appear to have been added later during maintenance and repair of the building. The perimeter of the building appears rests on post and peer foundation, but sections appear to rest directly on the soil. There are three open bays along the east elevation, which appear to have originally been four, but a dividing column was removed to expand the width of one of the bays (Figure 25). There are metal fence gates that have been added to the three open bays, which likely allow the barn to hold cattle if needed. The barn is in fair to good condition.

Figure 24. Photo showing Barn 3, west and south elevations, facing north.

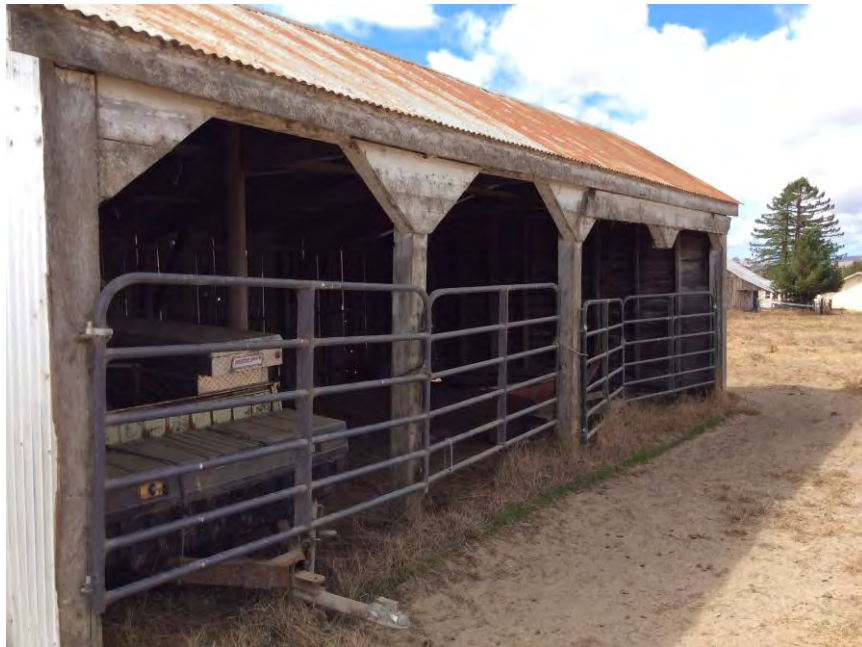
Figure 25. Photo showing Barn 3, east elevation, facing west.

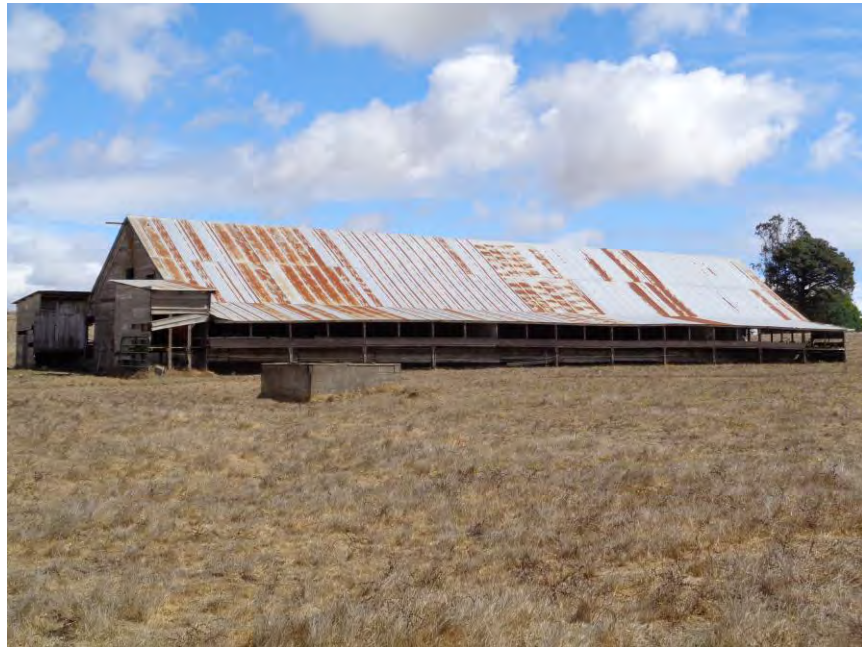
Barn 4 consists of a rectangular planned, front gable building, and a center corridor that is flanked on both sides by low-profile sections that were likely used as chicken pens and for hatching (Figure 26 and Figure 27). The center corridor allows air to flow through the center of the building, but also allows access to the chicken pens (Figure 28). There is chicken wire along areas within the interior and two shed attachments along the rear (north elevation) of the building that were accessed by stairs that have collapsed. The small rooms consist of a grain storage tanks, egg cartons, and an old bottle (Figure 29).

Figure 26. Photo showing Barn 4, west elevation, facing northeast.

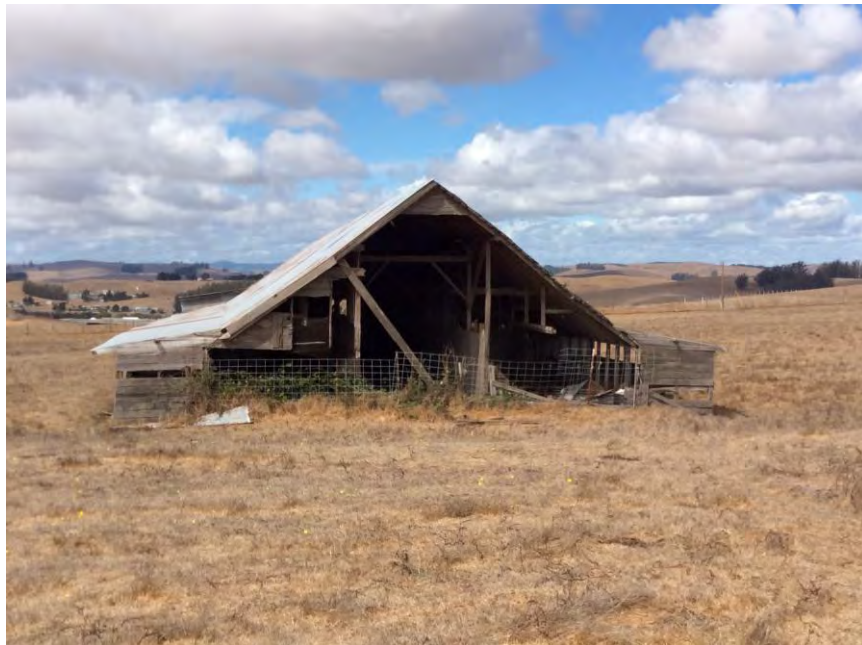
Figure 27. Photo showing Barn 4, south elevation, facing northwest.

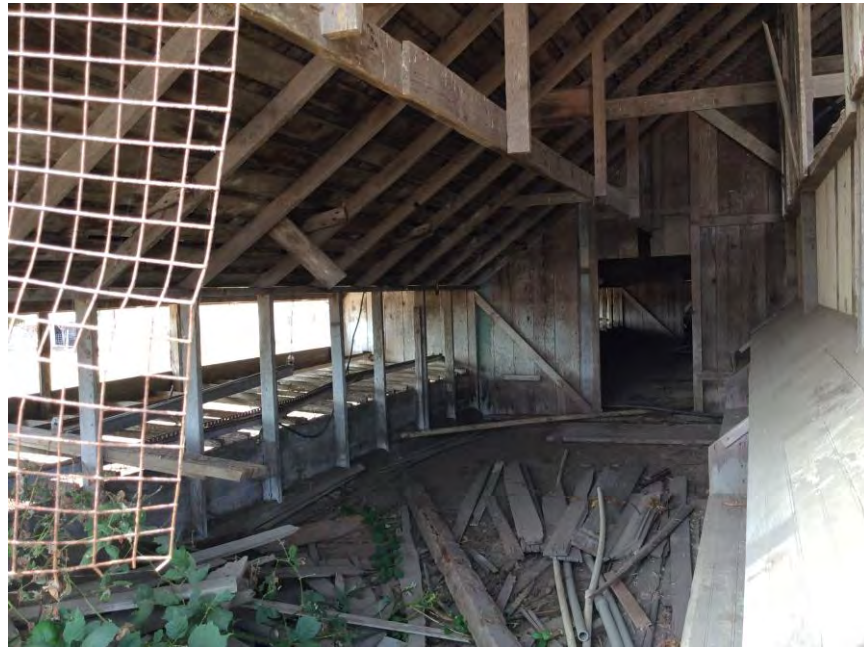
Figure 28. Photo showing the interior of Barn 4, facing northwest.

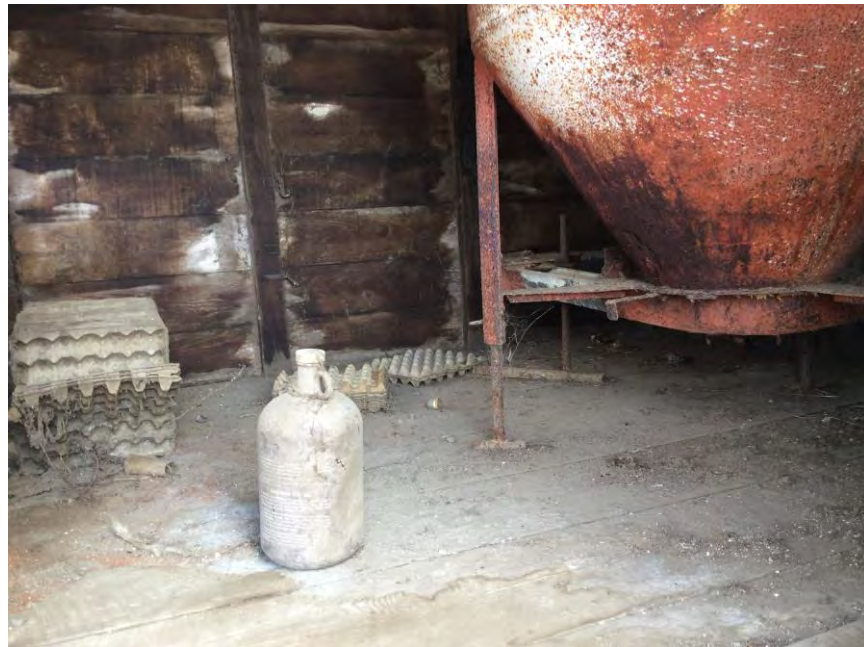
Figure 29. Photo showing the Interior of shed attachment of Barn 4, with grain tank, old bottle, and egg cartons.

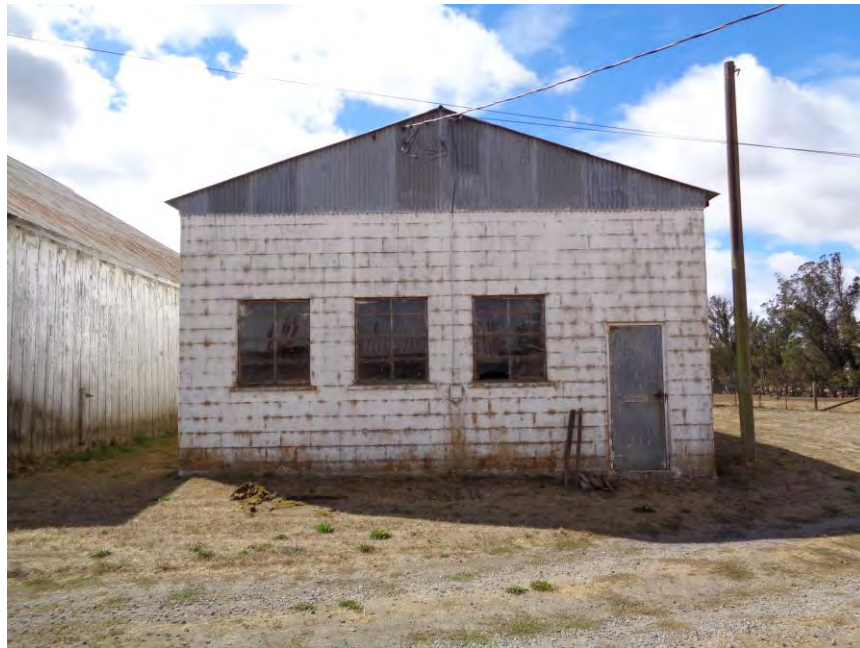
slab foundation and there are three metal barn doors along the north elevation that provide access the workshop. The building is wired for electricity and is in good condition.

Figure 30. Photo showing the east elevation of the ca. 1940 workshop building, facing southwest.

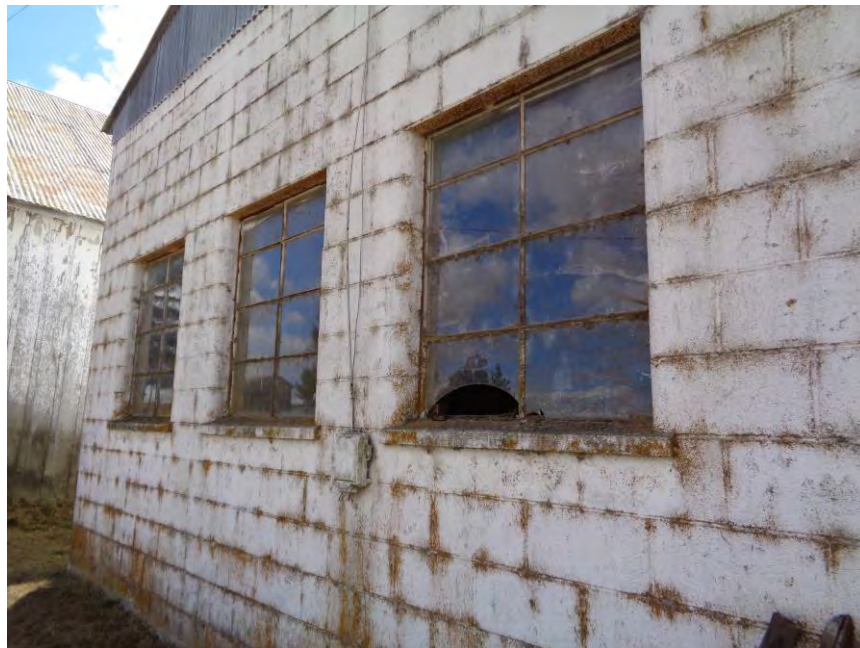
Figure 31. Photo showing the east elevation of the ca. 1940 workshop building, facing south.

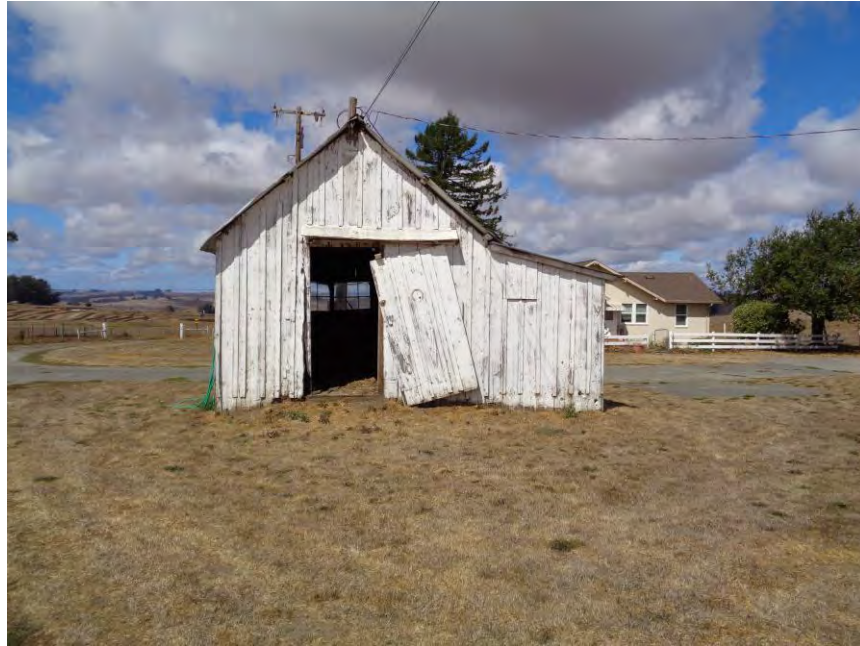
situated directly on the soil and is wired for electricity. The only entrance to the building is along the south elevation through a sliding barn door on metal rails. There are a pair of original six light wood windows along the north elevation, and a loft casement door (Figure 33). The interior of the building consists of wood floors and a workbench that appear to be original

Figure 32. Photo showing the south elevation of Storage Shed 1, facing northwest.

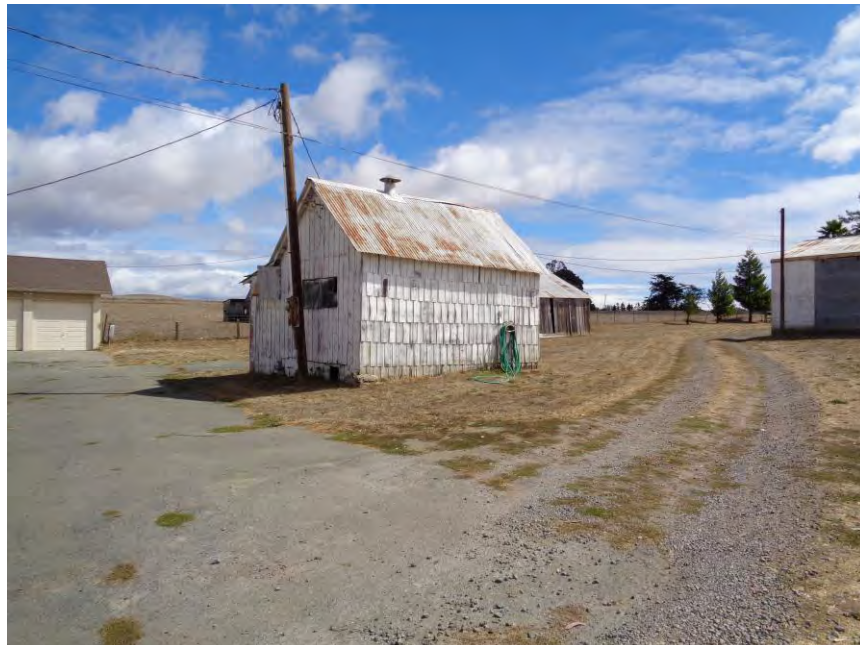
Figure 33. Photo showing Storage Shed 1, north and west elevations, facing east.

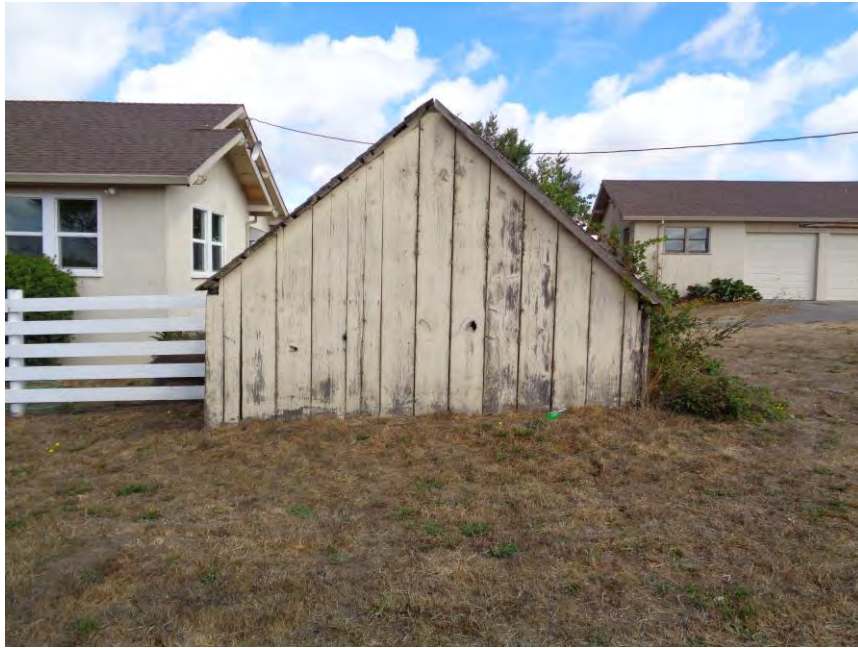
Storage Shed 2 is a front gable, low-profile building that is clad in vertical wood boards that are laid flush (Figure 34). There is a single-entry door along the east elevation. The building was likely use for

storing preserved foods and the floor may also be dug out to allow for storage below the ground level; however, the interior of the building was not accessible during the field survey.

Figure 34. Photo showing Storage Shed 2, west elevation, facing northeast.
